# Access Compliance Report

## Public Rights-of-Way

### (Curb Ramps)

| Intersection ID: 27236 | Main Street: BALLANTYNE CORPORATE PL | Cross Street: BRIXHAM HILL AV | Location: SE |

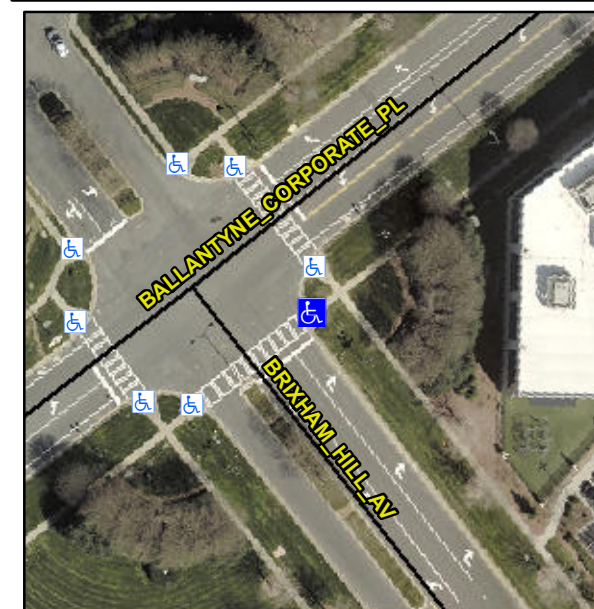
| ADA ID: 33C02EE11F92 | Ramp Type: Perp | Initial Pass/Fail: Fail | Overall Compliance: No |
| Severity Score: 25 | | | |

**R304.2.2**

| Compliance | Description | Data | Compliance | Description | Data |
|---|---|---|---|---|---|
| N/A | Ramp Length (in) | 101.0 | No | Ramp Slope (%) | 12.9 |

**Remove & Replace Entire Ramp.**

**\$ 1850.00**

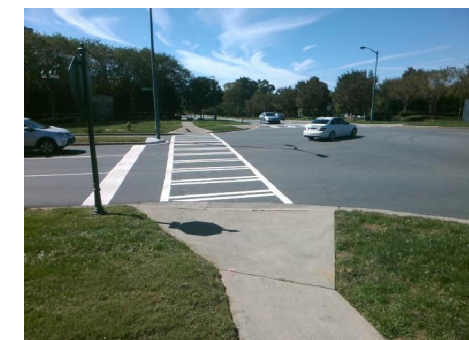
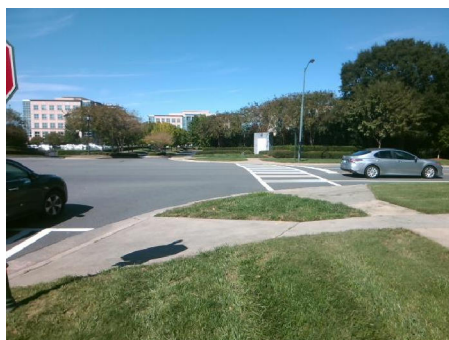
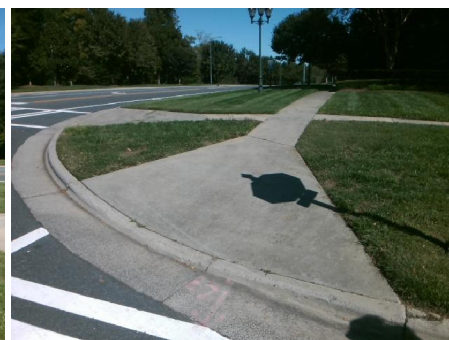
| Compliance | Description | Data | Compliance | Description | Data |
|---|---|---|---|---|---|
| Yes | Ramp Width (in) | 48.0 | Yes | Ramp XSlope (%) | 0.2 |
| | | | Yes | Surface Condition? (G/P) | Good |
