## Access Compliance Report Public Rights-of-Way (Curb Ramps)

Intersection ID: 10558Main Street: CLEMSON\_AVCross Street: SPENCER\_STLocation: NEADA ID: 33D0996B650BRamp Type: PerpInitial Pass/Fail: FailOverall Compliance: NoSeverity Score: 58.75

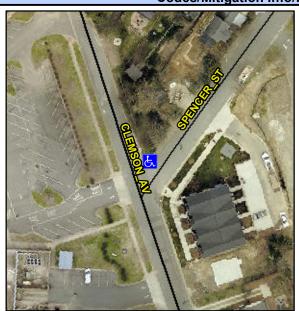
N/A	Ramp Length (in)	58.0	No	Ramp Slope (%)	12.4
No	Ramp Width (in)	38.0	No	Ramp XSlope (%)	7.8
N/A	Flare Type LT	N/A	N/A	Flare Type RT	N/A
N/A	Flare Slope LT (%)	N/A	N/A	Flare Slope RT (%)	N/A
N/A	Flare Traversable LT?	N/A	N/A	Flare Traversable RT?	N/A
N/A	Landing Length (in)	N/A	N/A	DWS Provided?	N/A
N/A	Landing Width (in)	N/A	N/A	DWS Contrast?	N/A
N/A	Landing Slope (%)	N/A	N/A	DWS Length (in)	N/A
N/A	Landing X Slope (%)	N/A	N/A	DWS Full Width?	N/A
N/A	Landing Curb? (Y/N)	N/A	N/A	DWS Offset (in)	N/A
N/A	Shared Landing?	N/A		()	
N/A	Gutter Ponding?	N/A	N/A	Gutter Slope (%)	N/A
N/A	Gutter Lip Ht (in)	N/A	N/A	Gutter X Slope (%)	N/A
N/A	Painted X Walk1?	No	N/A	Painted X Walk2?	N/A
	X Walk 1 Direction	To SW		X Walk 2 Direction	N/A
N/A	X Walk 1 Width (in)	N/A	N/A	X Walk 2 Width (in)	N/A
	X Walk 1 Slope (%)	3.5		X Walk 2 Slope (%)	N/A
	X Walk 1 X Slope (%)	1.0		X Walk 2 X Slope (%)	N/A
N/A	Ramp inside XWalk1?	N/A	N/A	Ramp inside XWalk2?	N/A

Possible Solutions:	Compliance Descript	ion
Remove & Replace Entire Ramp.	N/A Ramp Length (i	n)
	No Ramp Width (in	)
	N/A Flare Type LT	
	N/A Flare Slope LT	(%)
	N/A Flare Traversab	le LT
	N/A Landing Length	(in)
Surveyor Notes:	N/A Landing Width (	in)
N/A	N/A Landing Slope (	(%)
	N/A Landing X Slope	e (%)
	N/A Landing Curb?	(Y/N)
	N/A Shared Landing	J?
PROW/ADA:	N/A Gutter Ponding	?
R304.5.1, R304.2.2, R304.5.3	N/A Gutter Lip Ht (ir	1)
,	N/A Painted X Walk	1?
	X Walk 1 Direct	ion
	N/A X Walk 1 Width	(in)
	X Walk 1 Slope	(%)
	X Walk 1 X Slop	e (%
	N/A Ramp inside XV	Valk1

Total Cost:	\$ 1850.00
