Access Compliance Report Public Rights-of-Way (Curb Ramps)

Intersection ID: 20061 Main Street: S_TRYON_ST Cross Street: YORKHILLS_DR Location: NW **Overall Compliance: No ADA ID: 33D2EDD0024E** Ramp Type: Perp Initial Pass/Fail: Fail Severity Score: 13.75

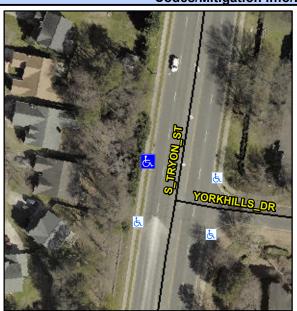
Field Measureme Compliance Description		Data	Compliance Description		Data
N/A	Ramp Length (in)	91.0	No	Ramp Slope (%)	9.2
Yes	Ramp Width (in)	48.0	Yes	Ramp XSlope (%)	2.4
N/A	Flare Type LT	N/A	N/A	Flare Type RT	N/A
N/A	Flare Slope LT (%)	N/A	N/A	Flare Slope RT (%)	N/A
N/A	Flare Traversable LT?	N/A	N/A	Flare Traversable RT?	N/A
N/A	Landing Length (in)	N/A	N/A	DWS Provided?	N/A
N/A	Landing Width (in)	N/A	N/A	DWS Contrast?	N/A
N/A	Landing Slope (%)	N/A	N/A	DWS Length (in)	N/A
N/A	Landing X Slope (%)	N/A	N/A	DWS Full Width?	N/A
N/A	Landing Curb? (Y/N)	N/A	N/A	DWS Offset (in)	N/A
N/A	Shared Landing?	N/A			
N/A	Gutter Ponding?	N/A	N/A	Gutter Slope (%)	N/A
N/A	Gutter Lip Ht (in)	N/A	N/A	Gutter X Slope (%)	N/A
N/A	Painted X Walk1?	No	N/A	Painted X Walk2?	N/A
	X Walk 1 Direction	To E		X Walk 2 Direction	N/A
N/A	X Walk 1 Width (in)	N/A	N/A	X Walk 2 Width (in)	N/A
	X Walk 1 Slope (%)	1.6		X Walk 2 Slope (%)	N/A
	X Walk 1 X Slope (%)	2.6		X Walk 2 X Slope (%)	N/A

Possible Solutions:	Co
Remove & Replace Entire Ramp.	N/
·	Ye
	N/
	N/
	N/
	N/
Surveyor Notes:	N/
N/A	N/
	N/
	N/
	N/
PROW/ADA:	N/
Not Found, R304.2.2	N/
	N/
	N/
	N/
