# Access Compliance Report

## Public Rights-of-Way

### (Curb Ramps)

Intersection ID: 10569	Main Street: PLYMOUTH_AV	Cross Street: BANCROFT_ST	Location:	N
ADA ID: 33D3B0418358	Ramp Type: PerpDiag	Initial Pass/Fail: Fail	Overall Compliance: No	Severity Score: 22.5
Codes/Mitigation Info/Possible Solution		Field Measurements/Component Compliance

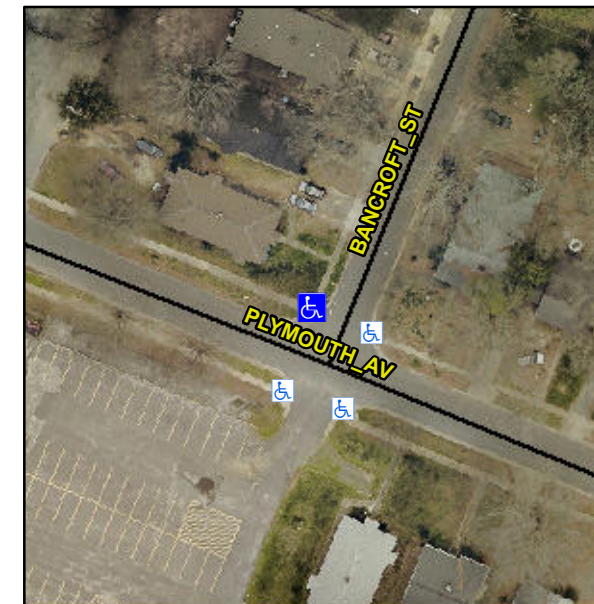
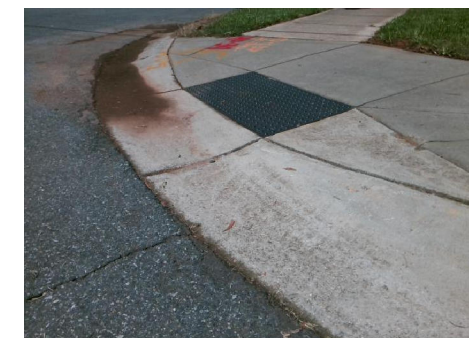
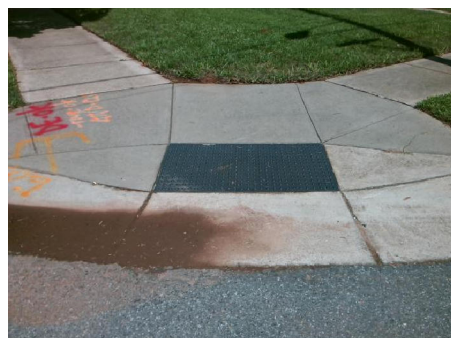
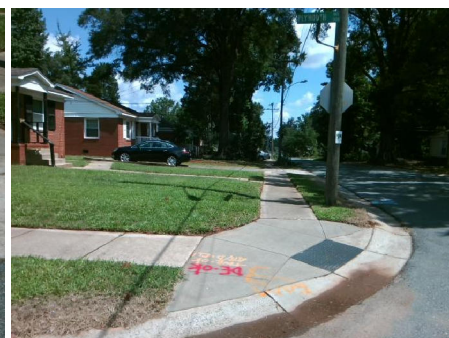
**Not Found, R304.5.1, R304.2.2, R304.5.3**

Compliance	Description	Data	Compliance	Description	Data
N/A	Ramp Length (in)	25.0	No	Ramp Slope (%)	9.3
No	Ramp Width (in)	47.0	No	Ramp XSlope (%)	2.2
N/A	Flare Type LT	N/A	N/A	Flare Type RT	N/A
N/A	Flare Slope LT (%)	N/A	N/A	Flare Slope RT (%)	N/A
N/A	Flare Traversable LT?	N/A	N/A	Flare Traversable RT?	N/A
N/A	Landing Length (in)	N/A	N/A	DWS Provided?	N/A
N/A	Landing Width (in)	N/A	N/A	DWS Contrast?	N/A
N/A	Landing Slope (%)	N/A	N/A	DWS Length (in)	N/A
N/A	Landing X Slope (%)	N/A	N/A	DWS Full Width?	N/A
N/A	Landing Curb? (Y/N)	N/A	N/A	DWS Offset (in)	N/A
N/A	Shared Landing?	N/A			
N/A	Gutter Ponding?	Yes	N/A	Gutter Slope (%)	N/A
N/A	Gutter Lip Ht (in)	N/A	N/A	Gutter X Slope (%)	N/A
N/A	Painted X Walk1?	No	N/A	Painted X Walk2?	No
	X Walk 1 Direction	To SW		X Walk 2 Direction	To SE
N/A	X Walk 1 Width (in)	N/A	N/A	X Walk 2 Width (in)	N/A
	X Walk 1 Slope (%)	3.2		X Walk 2 Slope (%)	1.1
	X Walk 1 X Slope (%)	0.4		X Walk 2 X Slope (%)	2.9

N/A	Ramp inside XWalk1?	N/A	N/A	Ramp inside XWalk2?	N/A
	Road Slope (%)	0.9	N/A	Clear Space?	N/A
	Road X Slope (%)	1.1	N/A	Clear Space to XWalk (in)	N/A
N/A	Any Obstructions?	N/A	N/A	Storm Grate/Utility Hazard?	N/A
	Obstruction Type			Storm Grate/Utility Type	
		N/A			N/A
		Yes		Surface Condition? (G/P)	Good

**Remove & Replace Curb Ramp With Two New Directional Ramps or Equivalent.**
