# Access Compliance Report

## Public Rights-of-Way

### (Curb Ramps)

Intersection ID: N/A	Main Street: NEW_FASHION_WY	Cross Street: OUTLETS_BV	Location: NW
ADA ID: 33D6C5E88981	Ramp Type: PerpDiag	Initial Pass/Fail: Fail	Overall Compliance: No
		Severity Score: 12.5

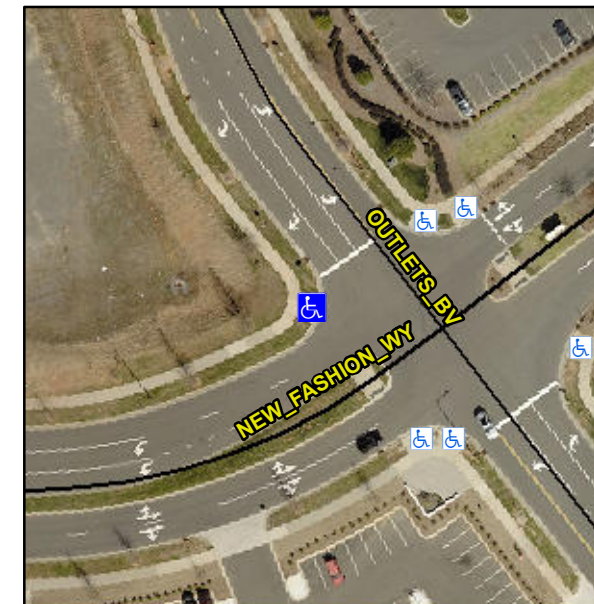
Compliance	Description	Data	Compliance	Description	Data
N/A	Ramp Length (in)	96.0	Yes	Ramp Slope (%)	5.2
Yes	Ramp Width (in)	49.0	No	Ramp XSlope (%)	5.7
N/A	Flare Type LT	N/A	N/A	Flare Type RT	N/A
N/A	Flare Slope LT (%)	N/A	N/A	Flare Slope RT (%)	N/A
N/A	Flare Traversable LT?	N/A	N/A	Flare Traversable RT?	N/A
N/A	Landing Length (in)	N/A	N/A	DWS Provided?	N/A
N/A	Landing Width (in)	N/A	N/A	DWS Contrast?	N/A
N/A	Landing Slope (%)	N/A	N/A	DWS Length (in)	N/A
N/A	Landing X Slope (%)	N/A	N/A	DWS Full Width?	N/A
N/A	Landing Curb? (Y/N)	N/A	N/A	DWS Offset (in)	N/A
N/A	Shared Landing?	N/A			
N/A	Gutter Ponding?	N/A	N/A	Gutter Slope (%)	N/A
N/A	Gutter Lip Ht (in)	N/A	N/A	Gutter X Slope (%)	N/A
N/A	Painted X Walk1?	No	N/A	Painted X Walk2?	No
	X Walk 1 Direction	To SE		X Walk 2 Direction	To NE
N/A	X Walk 1 Width (in)	N/A	N/A	X Walk 2 Width (in)	N/A
	X Walk 1 Slope (%)	2.8		X Walk 2 Slope (%)	4.9
	X Walk 1 X Slope (%)	7.4		X Walk 2 X Slope (%)	1.7

N/A	Ramp inside XWalk1?	N/A	N/A	Ramp inside XWalk2?	N/A
	Road Slope (%)	4.3	N/A	Clear Space?	N/A
	Road X Slope (%)	6.4	N/A	Clear Space to XWalk (in)	N/A
N/A	Any Obstructions?	N/A	N/A	Storm Grate/Utility Hazard?	N/A
	Obstruction Type			Storm Grate/Utility Type	
		N/A			N/A
			Yes	Surface Condition? (G/P)	Good

**Remove & Replace Curb Ramp With Two New Directional Ramps or Equivalent.**

**R304.5.3**
