Access Compliance Report

Public Rights-of-Way

(Curb Ramps)

Intersection ID: 46754	Main Street: SUPERIOR_ST	Cross Street: TAHOE_DR	Location: NW
ADA ID: 33D7CD37F9A2	Ramp Type: BlendTrans1	Initial Pass/Fail: Fail	Overall Compliance: No
			Severity Score: 21.25

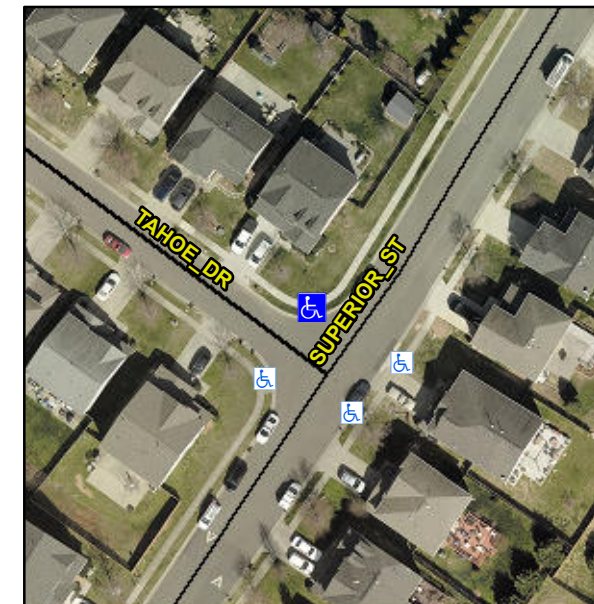
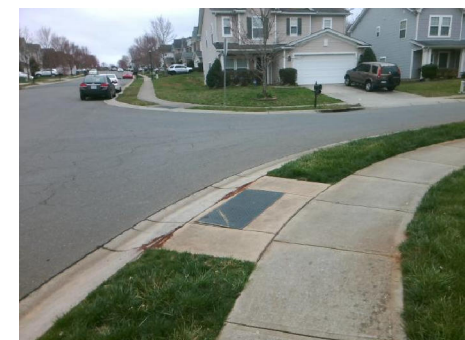
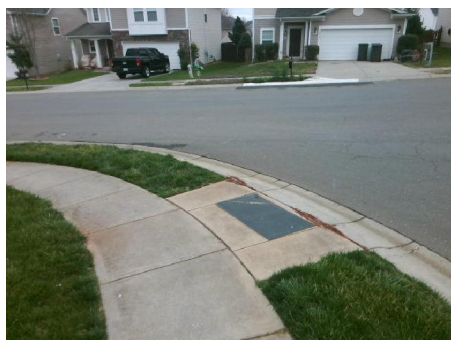
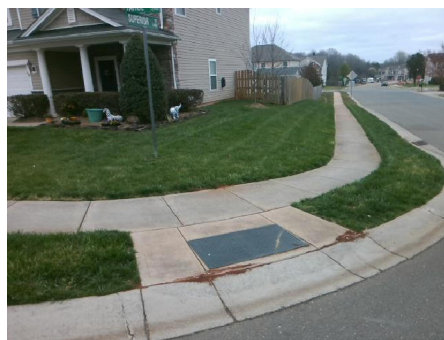
Not Found, R304.5.1, R304.5.3

Compliance	Description	Data	Compliance	Description	Data
N/A	Ramp Length (in)	46.0	Yes	BlendTrans Slope (%)	3.3
No	Ramp Width (in)	45.0	No	BlendTrans XSlope (%)	6.8
N/A	Flare Type LT	N/A	N/A	Flare Type RT	N/A
N/A	Flare Slope LT (%)	N/A	N/A	Flare Slope RT (%)	N/A
N/A	Flare Traversable LT?	N/A	N/A	Flare Traversable RT?	N/A
N/A	Landing Length (in)	N/A	N/A	DWS Provided?	N/A
N/A	Landing Width (in)	N/A	N/A	DWS Contrast?	N/A
N/A	Landing Slope (%)	N/A	N/A	DWS Length (in)	N/A
N/A	Landing X Slope (%)	N/A	N/A	DWS Full Width?	N/A
N/A	Landing Curb? (Y/N)	N/A	N/A	DWS Offset (in)	N/A
N/A	Shared Landing?	N/A			
N/A	Gutter Ponding?	N/A	N/A	Gutter Slope (%)	N/A
N/A	Gutter Lip Ht (in)	N/A	N/A	Gutter X Slope (%)	N/A
N/A	Painted X Walk1?	No	N/A	Painted X Walk2?	No
	X Walk 1 Direction	To SW		X Walk 2 Direction	To SE
	X Walk 1 Width (in)	N/A		X Walk 2 Width (in)	N/A
	X Walk 1 Slope (%)	4.5		X Walk 2 Slope (%)	1.2
	X Walk 1 X Slope (%)	3.8		X Walk 2 X Slope (%)	4.5

N/A	Ramp inside XWalk1?	N/A	N/A	Ramp inside XWalk2?	N/A
	Road Slope (%)	4.5		Clear Space?	N/A
	Road X Slope (%)	2.6	N/A	Clear Space to XWalk (in)	N/A
N/A	Any Obstructions?	N/A	N/A	Storm Grate/Utility Hazard?	N/A
	Obstruction Type			Storm Grate/Utility Type	
		N/A			N/A
			Yes	Surface Condition? (G/P)	Good
			No	Curb Slope (%)	13.6

Remove & Replace Curb Ramp With Two New Directional Ramps or Equivalent.
