# Access Compliance Report

## Public Rights-of-Way

### (Curb Ramps)

Intersection ID: 8985	Main Street: ENNIS_AV	Cross Street: GRIMES_ST	Location: SE
ADA ID: 33E89BA15F0B	Ramp Type: BlendTrans1	Initial Pass/Fail: Fail	Overall Compliance: No
Severity Score: 8.75			
Codes/Mitigation Info/Possible Solution		Field Measurements/Component Compliance

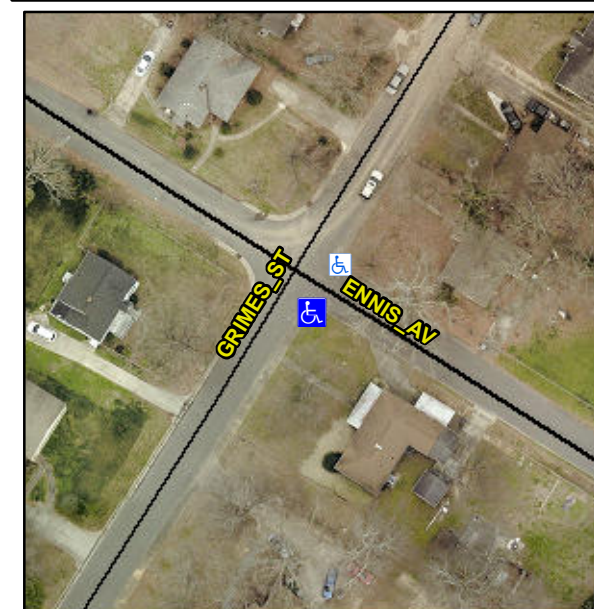
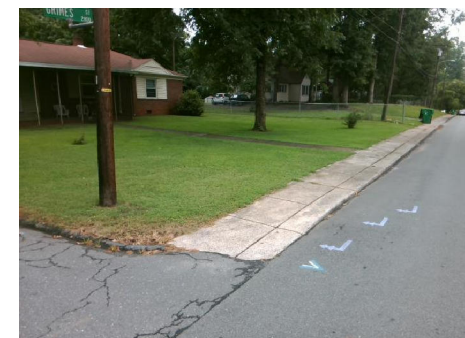
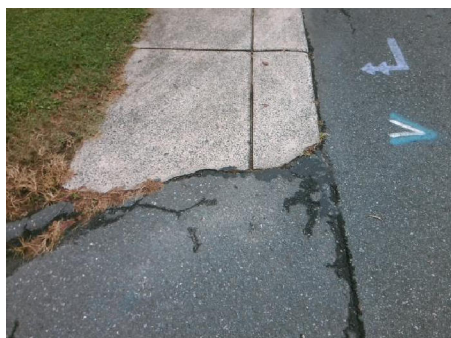
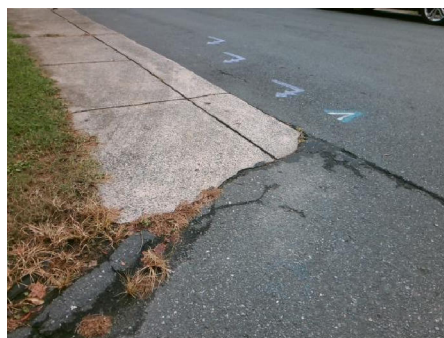
**NO CURB**

Compliance	Description	Data	Compliance	Description	Data
N/A	Ramp Length (in)	43.5	Yes	BlendTrans Slope (%)	2.5
No	Ramp Width (in)	38.0	Yes	BlendTrans XSlope (%)	0.5
N/A	Flare Type LT	N/A	N/A	Flare Type RT	N/A
N/A	Flare Slope LT (%)	N/A	N/A	Flare Slope RT (%)	N/A
N/A	Flare Traversable LT?	N/A	N/A	Flare Traversable RT?	N/A
N/A	Landing Length (in)	N/A	N/A	DWS Provided?	N/A
N/A	Landing Width (in)	N/A	N/A	DWS Contrast?	N/A
N/A	Landing Slope (%)	N/A	N/A	DWS Length (in)	N/A
N/A	Landing X Slope (%)	N/A	N/A	DWS Full Width?	N/A
N/A	Landing Curb? (Y/N)	N/A	N/A	DWS Offset (in)	N/A
N/A	Shared Landing?	N/A			
N/A	Gutter Ponding?	N/A	N/A	Gutter Slope (%)	N/A
N/A	Gutter Lip Ht (in)	N/A	N/A	Gutter X Slope (%)	N/A
N/A	Painted X Walk1?	No	N/A	Painted X Walk2?	N/A
	X Walk 1 Direction	To NE		X Walk 2 Direction	N/A
	X Walk 1 Width (in)	N/A		X Walk 2 Width (in)	N/A
	X Walk 1 Slope (%)	3.6		X Walk 2 Slope (%)	N/A
	X Walk 1 X Slope (%)	0.9		X Walk 2 X Slope (%)	N/A

N/A	Ramp inside XWalk1?	N/A	N/A	Ramp inside XWalk2?	N/A
	Road Slope (%)	0.9		Clear Space?	N/A
	Road X Slope (%)	3.6	N/A	Clear Space to XWalk (in)	N/A
N/A	Any Obstructions?	N/A	N/A	Storm Grate/Utility Hazard?	N/A
	Obstruction Type			Storm Grate/Utility Type	
		N/A			N/A
			Yes	Surface Condition? (G/P)	Good
			N/A	Curb Slope (%)	N/A

**Remove & Replace Curb Ramp With Two New Directional Ramps or Equivalent.**

**R304.5.1**
