# Access Compliance Report

## Public Rights-of-Way

### (Curb Ramps)

| Intersection ID: 27418 | Main Street: BALLANTYNE COMMONS PY | Cross Street: BALLANTYNE TRACE CT | Location: NE |

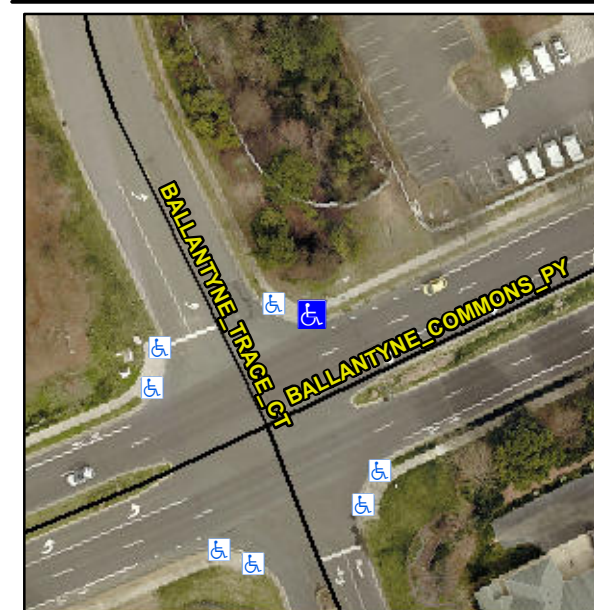
**Not Found, R304.5.1, R304.5.3**

| Compliance | Description | Data | Compliance | Description | Data |
|---|---|---|---|---|---|
| N/A | Ramp Length (in) | 96.0 | Yes | Ramp Slope (%) | 5.2 |
| No | Ramp Width (in) | 47.5 | No | Ramp XSlope (%) | 10.4 |

**Remove & Replace Entire Ramp.**

Total Cost: \$ 1850.00
