# Access Compliance Report

## Public Rights-of-Way

### (Curb Ramps)

Intersection ID: N/A	Main Street: SHARON_VIEW_RD	Cross Street: OHILLIOS_GATE_DR	Location: NW
ADA ID: 33EE01393D7F	Ramp Type: BlendTrans2	Initial Pass/Fail: Fail	Overall Compliance: No
		Severity Score: 1.25

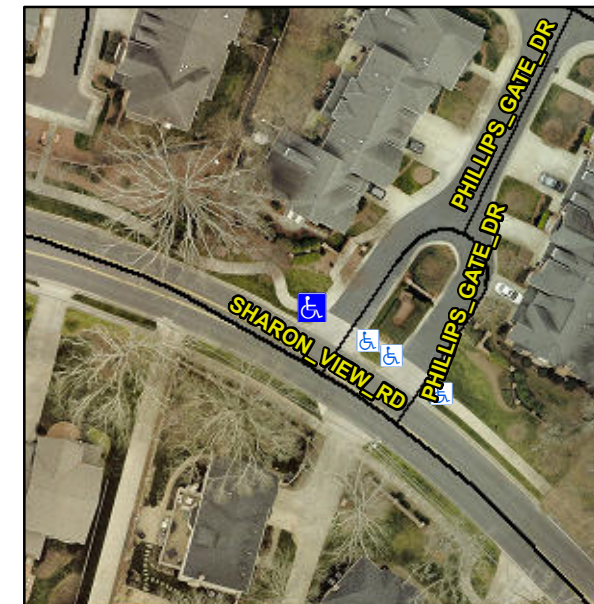
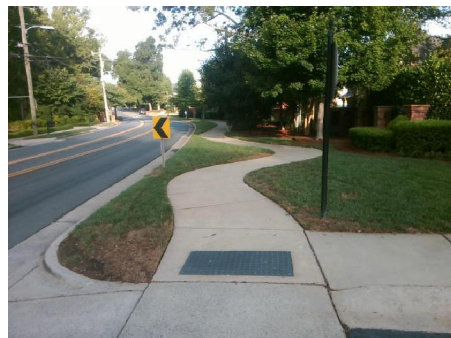
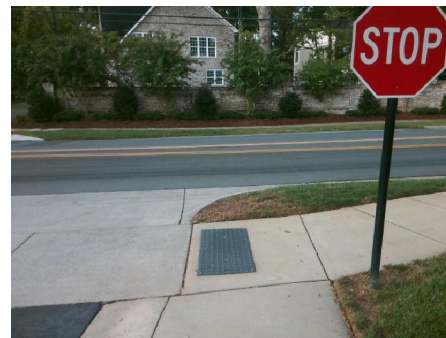
**NO CURB LINE**

Compliance	Description	Data	Compliance	Description	Data
N/A	Ramp Length (in)	58.0	Yes	BlendTrans Slope (%)	2.5
Yes	Ramp Width (in)	74.0	No	BlendTrans XSlope (%)	3.4
N/A	Flare Type LT	N/A	N/A	Flare Type RT	N/A
N/A	Flare Slope LT (%)	N/A	N/A	Flare Slope RT (%)	N/A
N/A	Flare Traversable LT?	N/A	N/A	Flare Traversable RT?	N/A
N/A	Landing Length (in)	N/A	N/A	DWS Provided?	N/A
N/A	Landing Width (in)	N/A	N/A	DWS Contrast?	N/A
N/A	Landing Slope (%)	N/A	N/A	DWS Length (in)	N/A
N/A	Landing X Slope (%)	N/A	N/A	DWS Full Width?	N/A
N/A	Landing Curb? (Y/N)	N/A	N/A	DWS Offset (in)	N/A
N/A	Shared Landing?	N/A			
N/A	Gutter Ponding?	N/A	N/A	Gutter Slope (%)	N/A
N/A	Gutter Lip Ht (in)	N/A	N/A	Gutter X Slope (%)	N/A
N/A	Painted X Walk1?	No	N/A	Painted X Walk2?	N/A
	X Walk 1 Direction	To SE		X Walk 2 Direction	N/A
	X Walk 1 Width (in)	N/A		X Walk 2 Width (in)	N/A
	X Walk 1 Slope (%)	0.6		X Walk 2 Slope (%)	N/A
	X Walk 1 X Slope (%)	2.2		X Walk 2 X Slope (%)	N/A

N/A	Ramp inside XWalk1?	N/A	N/A	Ramp inside XWalk2?	N/A
	Road Slope (%)	2.2		Clear Space?	N/A
	Road X Slope (%)	0.6	N/A	Clear Space to XWalk (in)	N/A
N/A	Any Obstructions?	N/A	N/A	Storm Grate/Utility Hazard?	N/A
	Obstruction Type			Storm Grate/Utility Type	
		N/A			N/A
			Yes	Surface Condition? (G/P)	Good
			N/A	Curb Slope (%)	N/A

**Remove & Replace Curb Ramp With Two New Directional Ramps or Equivalent.**

**R304.5.3**
