Intersection ID: 11597	Main Street: E_20TH_ST	Cross Street: SEIGLE_AV	Location:	E
ADA ID: 33F0B4BF09AC	Ramp Type: Perp	Initial Pass/Fail: Fail	Overall Compliance: No	Severity Score: 13.75

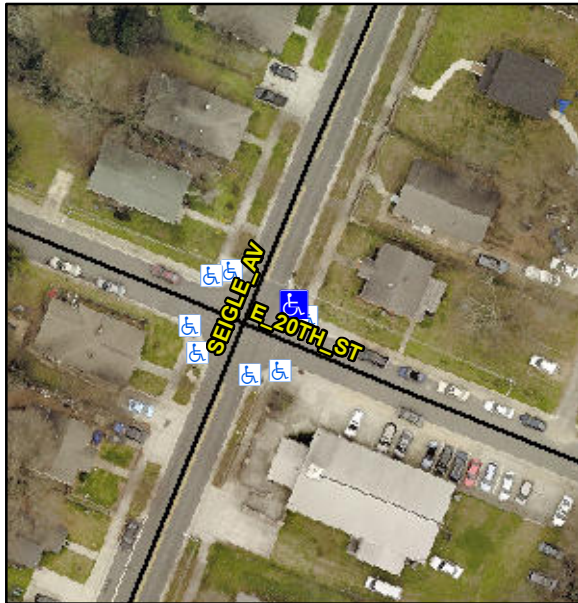
Not Found, R304.2.2

Possible Solutions:			Compliance	Description	Data	Compliance	Description	Data
Remove & Replace Entire Ramp.			N/A	Ramp Length (in)	78.0	No	Ramp Slope (%)	9.3
			Yes	Ramp Width (in)	48.0	Yes	Ramp XSlope (%)	3.8
			N/A	Flare Type LT	N/A	N/A	Flare Type RT	N/A
			N/A	Flare Slope LT (%)	N/A	N/A	Flare Slope RT (%)	N/A
			N/A	Flare Traversable LT?	N/A	N/A	Flare Traversable RT?	N/A
			N/A	Landing Length (in)	N/A	N/A	DWS Provided?	N/A
Surveyor Notes:			N/A	Landing Width (in)	N/A	N/A	DWS Contrast?	N/A
	N/A		N/A	Landing Slope (%)	N/A	N/A	DWS Length (in)	N/A
			N/A	Landing X Slope (%)	N/A	N/A	DWS Full Width?	N/A
			N/A	Landing Curb? (Y/N)	N/A	N/A	DWS Offset (in)	N/A
			N/A	Shared Landing?	N/A			
PROW/ADA:			N/A	Gutter Ponding?	N/A	N/A	Gutter Slope (%)	N/A
	Not Found, R304.2.2		N/A	Gutter Lip Ht (in)	N/A	N/A	Gutter X Slope (%)	N/A
			N/A	Painted X Walk1?	No	N/A	Painted X Walk2?	N/A
				X Walk 1 Direction	To NW		X Walk 2 Direction	N/A

N/A	X Walk 1 Width (in)	N/A	N/A	X Walk 2 Width (in)	N/A
				X Walk 1 Slope (%)	2.2		X Walk 2 Slope (%)	N/A
				X Walk 1 X Slope (%)	4.3		X Walk 2 X Slope (%)	N/A
			N/A	Ramp inside XWalk1?	N/A	N/A	Ramp inside XWalk2?	N/A
				Road Slope (%)	N/A	N/A	Clear Space?	N/A
				Road X Slope (%)	N/A	N/A	Clear Space to XWalk (in)	N/A
			N/A	Any Obstructions?	N/A	N/A	Storm Grate/Utility Hazard?	N/A
Total Cost:	\$	1850.00		Obstruction Type			Storm Grate/Utility Type	
					N/A			N/A
						Yes	Surface Condition? (G/P)	Good

Possible Solutions:

Remove & Replace Entire Ramp.
