Access Compliance Report Public Rights-of-Way (Curb Ramps)

Intersection ID: 10021330 Main Street: BLAKENEY_HEATH_RD					N/A	Location:	NW			
ADA ID: 33F278AB4296 Ramp Type: Perp			Initial Pass/Fail: Fail Overall Compliance: No				o Severity Score:	1.25		
Codes/Mitigation Info/Possible Solution				Field Measurements/Component Compliance						
	111	Possible Solutions:		Compliance Description Data Compliance				liance Description	Data	
de transferration	1/1/	Remove & Replace Entire Ramp		N/A	Ramp Length (in)	84.0	Yes	Ramp Slope (%)	5.9	
	1/18			Yes	Ramp Width (in)	48.0	No	Ramp XSlope (%)	2.2	
17 Jan 20 14	11.3			N/A	Flare Type LT	N/A	N/A	Flare Type RT	N/A

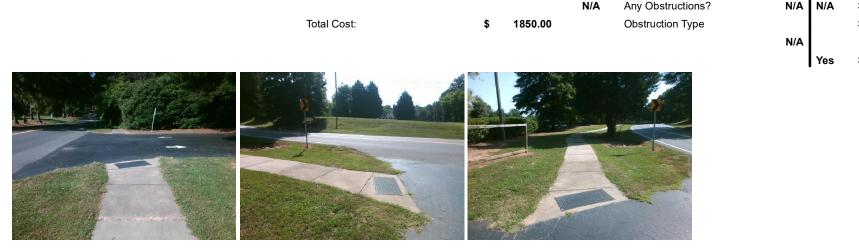
14. 534	Not Found, R304.5.3		N/A	Gutter Lip Ht (in)	N/A	N/A	Gutter X Slope (%)	N/A	
				N/A	Painted X Walk1?	No	N/A	Painted X Walk2?	N/A	
	8.3				X Walk 1 Direction	To SE		X Walk 2 Direction	N/A	
				N/A	X Walk 1 Width (in)	N/A	N/A	X Walk 2 Width (in)	N/A	
Street 1 Name	ENTRANCE				X Walk 1 Slope (%)	2.7		X Walk 2 Slope (%)	N/A	
Stop Condition-Street 2	StopSign				X Walk 1 X Slope (%)	0.0		X Walk 2 X Slope (%)	N/A	
Street 2 Name	N/A			N/A	Ramp inside XWalk1?	N/A	N/A	Ramp inside XWalk2?	N/A	
Stop Condition-Street 1	N/A				Road Slope (%)	N/A	N/A	Clear Space?	N/A	
					Road X Slope (%)	N/A	N/A	Clear Space to XWalk (in)	N/A	
				N/A	Any Obstructions?	N/A	N/A	Storm Grate/Utility Hazard?	N/A	
		Total Cost: \$	1850.00		Obstruction Type			Storm Grate/Utility Type		
						N/A			N/A
