Access Compliance Report

Public Rights-of-Way

(Curb Ramps)

Intersection ID: 15646	Main Street: BELTON_ST	Cross Street: GREYSTONE_RD	Location:	N
ADA ID: 33F50731B1E9	Ramp Type: PerpDiag	Initial Pass/Fail: Fail	Overall Compliance: No	Severity Score: 25

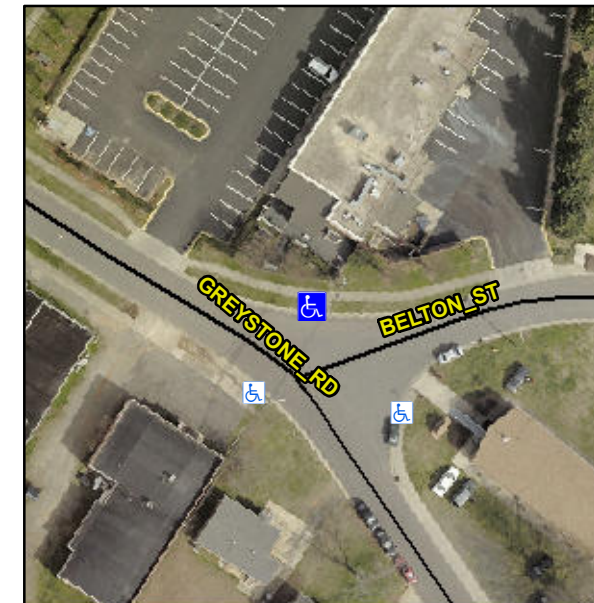
Not Found, R304.2.2, R304.5.3

Compliance	Description	Data	Compliance	Description	Data
N/A	Ramp Length (in)	80.0	No	Ramp Slope (%)	8.6
Yes	Ramp Width (in)	48.0	No	Ramp XSlope (%)	5.9
N/A	Flare Type LT	N/A	N/A	Flare Type RT	N/A
N/A	Flare Slope LT (%)	N/A	N/A	Flare Slope RT (%)	N/A
N/A	Flare Traversable LT?	N/A	N/A	Flare Traversable RT?	N/A
N/A	Landing Length (in)	N/A	N/A	DWS Provided?	N/A
N/A	Landing Width (in)	N/A	N/A	DWS Contrast?	N/A
N/A	Landing Slope (%)	N/A	N/A	DWS Length (in)	N/A
N/A	Landing X Slope (%)	N/A	N/A	DWS Full Width?	N/A
N/A	Landing Curb? (Y/N)	N/A	N/A	DWS Offset (in)	N/A
N/A	Shared Landing?	N/A			
N/A	Gutter Ponding?	N/A	N/A	Gutter Slope (%)	N/A
N/A	Gutter Lip Ht (in)	N/A	N/A	Gutter X Slope (%)	N/A
N/A	Painted X Walk1?	No	N/A	Painted X Walk2?	No
	X Walk 1 Direction	To SW		X Walk 2 Direction	To SE
N/A	X Walk 1 Width (in)	N/A	N/A	X Walk 2 Width (in)	N/A
	X Walk 1 Slope (%)	7.0		X Walk 2 Slope (%)	0.8
	X Walk 1 X Slope (%)	1.9		X Walk 2 X Slope (%)	7.7

N/A	Ramp inside XWalk1?	N/A	N/A	Ramp inside XWalk2?	N/A
	Road Slope (%)	4.3	N/A	Clear Space?	N/A
	Road X Slope (%)	5.2	N/A	Clear Space to XWalk (in)	N/A
N/A	Any Obstructions?	N/A	N/A	Storm Grate/Utility Hazard?	N/A
	Obstruction Type			Storm Grate/Utility Type	
		N/A			N/A
			Yes	Surface Condition? (G/P)	Good

Remove & Replace Curb Ramp With Two New Directional Ramps or Equivalent.
