Access Compliance Report

Public Rights-of-Way

(Curb Ramps)

Intersection ID: 15025	Main Street: DWIGHTWARE_BV	Cross Street: HEMSWORTH_TR	Location: SW
ADA ID: 33FE4AC18DA5	Ramp Type: PerpDiag	Initial Pass/Fail: Fail	Overall Compliance: No
		Severity Score: 25

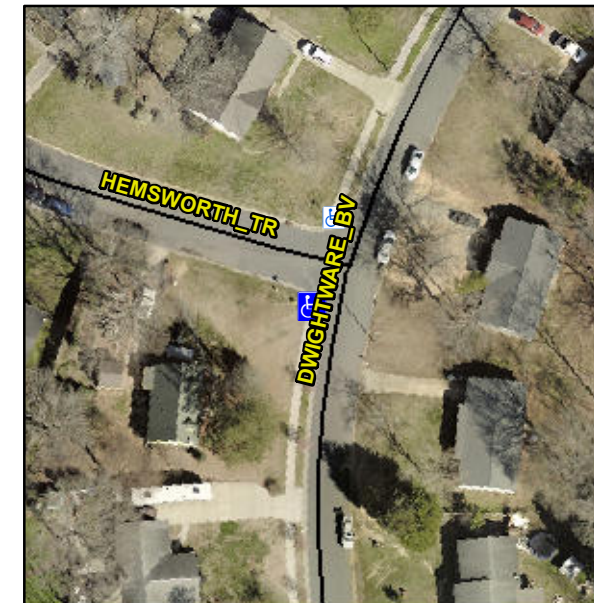
Not Found, R304.5.3

Compliance	Description	Data	Compliance	Description	Data
N/A	Ramp Length (in)	48.0	Yes	Ramp Slope (%)	6.0
Yes	Ramp Width (in)	48.0	No	Ramp XSlope (%)	9.0
N/A	Flare Type LT	N/A	N/A	Flare Type RT	N/A
N/A	Flare Slope LT (%)	N/A	N/A	Flare Slope RT (%)	N/A
N/A	Flare Traversable LT?	N/A	N/A	Flare Traversable RT?	N/A
N/A	Landing Length (in)	N/A	N/A	DWS Provided?	N/A
N/A	Landing Width (in)	N/A	N/A	DWS Contrast?	N/A
N/A	Landing Slope (%)	N/A	N/A	DWS Length (in)	N/A
N/A	Landing X Slope (%)	N/A	N/A	DWS Full Width?	N/A
N/A	Landing Curb? (Y/N)	N/A	N/A	DWS Offset (in)	N/A
N/A	Shared Landing?	N/A			
N/A	Gutter Ponding?	N/A	N/A	Gutter Slope (%)	N/A
N/A	Gutter Lip Ht (in)	N/A	N/A	Gutter X Slope (%)	N/A
N/A	Painted X Walk1?	No	N/A	Painted X Walk2?	No
	X Walk 1 Direction	To SE		X Walk 2 Direction	To NE
N/A	X Walk 1 Width (in)	N/A	N/A	X Walk 2 Width (in)	N/A
	X Walk 1 Slope (%)	5.0		X Walk 2 Slope (%)	10.6
	X Walk 1 X Slope (%)	9.8		X Walk 2 X Slope (%)	2.9

N/A	Ramp inside XWalk1?	N/A	N/A	Ramp inside XWalk2?	N/A
	Road Slope (%)	4.8	N/A	Clear Space?	N/A
	Road X Slope (%)	11.5	N/A	Clear Space to XWalk (in)	N/A
N/A	Any Obstructions?	N/A	N/A	Storm Grate/Utility Hazard?	N/A
	Obstruction Type			Storm Grate/Utility Type	
		N/A			N/A
			Yes	Surface Condition? (G/P)	Good

Remove & Replace Curb Ramp With Two New Directional Ramps or Equivalent.
