# Access Compliance Report

## Public Rights-of-Way

### (Curb Ramps)

Intersection ID: 21772	Main Street: DOVERSHIRE_RD	Cross Street: SARDIS_RD	Location:	NE
ADA ID: 33FF7B6305DC	Ramp Type: BlendTrans2	Initial Pass/Fail: Fail	Overall Compliance: No	Severity Score: 10
Codes/Mitigation Info/Possible Solution		Field Measurements/Component Compliance

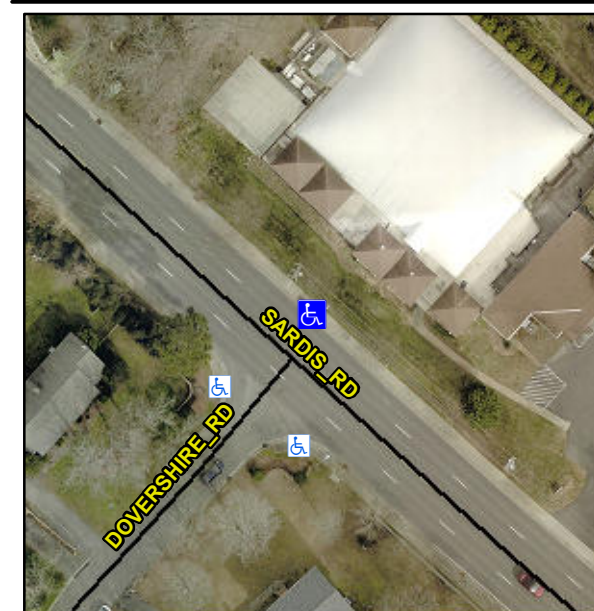
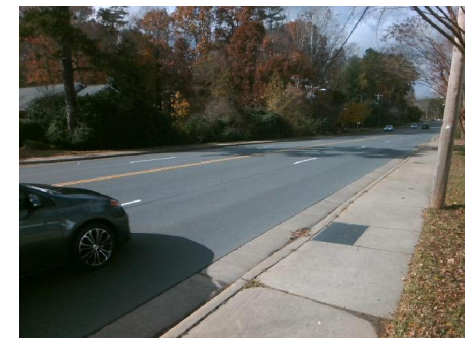
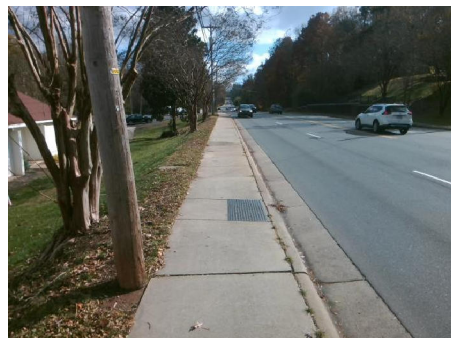
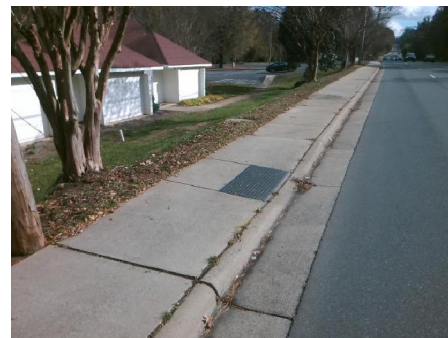
**Not Found, R304.5.1, R304.5.3**

Compliance	Description	Data	Compliance	Description	Data
N/A	Ramp Length (in)	60.0	Yes	BlendTrans Slope (%)	2.8
No	Ramp Width (in)	45.5	No	BlendTrans XSlope (%)	3.1
N/A	Flare Type LT	N/A	N/A	Flare Type RT	N/A
N/A	Flare Slope LT (%)	N/A	N/A	Flare Slope RT (%)	N/A
N/A	Flare Traversable LT?	N/A	N/A	Flare Traversable RT?	N/A
N/A	Landing Length (in)	N/A	N/A	DWS Provided?	N/A
N/A	Landing Width (in)	N/A	N/A	DWS Contrast?	N/A
N/A	Landing Slope (%)	N/A	N/A	DWS Length (in)	N/A
N/A	Landing X Slope (%)	N/A	N/A	DWS Full Width?	N/A
N/A	Landing Curb? (Y/N)	N/A	N/A	DWS Offset (in)	N/A
N/A	Shared Landing?	N/A			
N/A	Gutter Ponding?	N/A	N/A	Gutter Slope (%)	N/A
N/A	Gutter Lip Ht (in)	N/A	N/A	Gutter X Slope (%)	N/A
N/A	Painted X Walk1?	No	N/A	Painted X Walk2?	N/A
	X Walk 1 Direction	To SW		X Walk 2 Direction	N/A
	X Walk 1 Width (in)	N/A		X Walk 2 Width (in)	N/A
	X Walk 1 Slope (%)	0.8		X Walk 2 Slope (%)	N/A
	X Walk 1 X Slope (%)	1.9		X Walk 2 X Slope (%)	N/A

N/A	Ramp inside XWalk1?	N/A	N/A	Ramp inside XWalk2?	N/A
	Road Slope (%)	1.9		Clear Space?	N/A
	Road X Slope (%)	0.8	N/A	Clear Space to XWalk (in)	N/A
N/A	Any Obstructions?	N/A	N/A	Storm Grate/Utility Hazard?	N/A
	Obstruction Type			Storm Grate/Utility Type	
		N/A			N/A
			Yes	Surface Condition? (G/P)	Good
			No	Curb Slope (%)	12.5

**Remove & Replace Curb Ramp With Two New Directional Ramps or Equivalent.**
