Access Compliance Report

Public Rights-of-Way (Curb Ramps)

Intersection ID: 43848	Main Street: COZEN_WY	Cross Street: ROTHMAN_LN	Location: SW
ADA ID: 342AC577B99B	Ramp Type: PerpDiag	Initial Pass/Fail: Fail	Overall Compliance: No
		Severity Score: 12.5

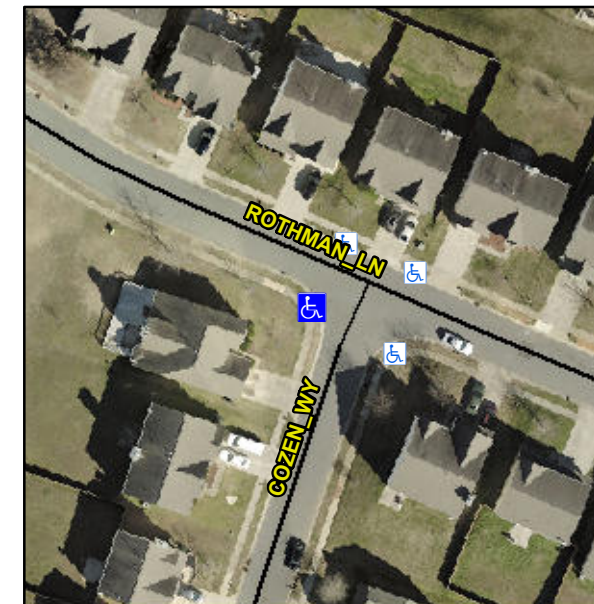
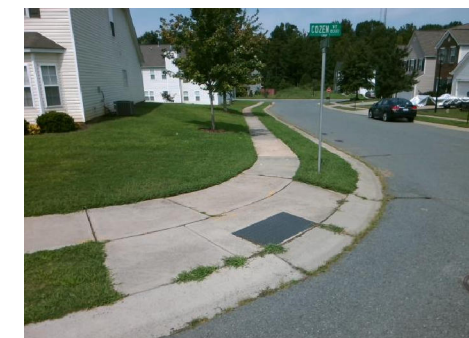
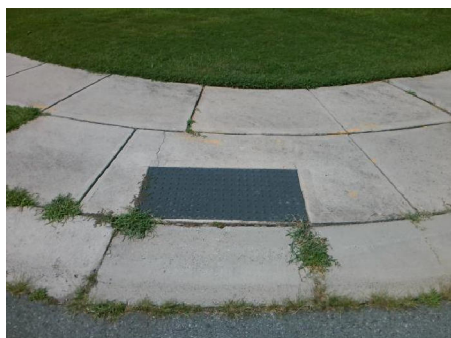
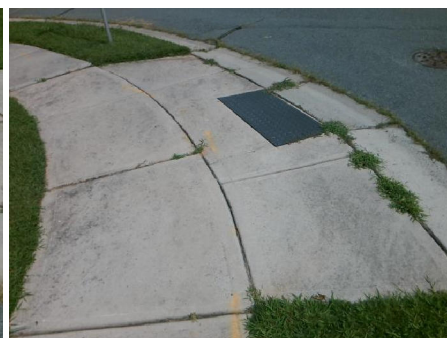
Not Found, R304.5.3

Compliance	Description	Data	Compliance	Description	Data
N/A	Ramp Length (in)	48.5	Yes	Ramp Slope (%)	6.2
Yes	Ramp Width (in)	82.0	No	Ramp XSlope (%)	6.2
N/A	Flare Type LT	N/A	N/A	Flare Type RT	N/A
N/A	Flare Slope LT (%)	N/A	N/A	Flare Slope RT (%)	N/A
N/A	Flare Traversable LT?	N/A	N/A	Flare Traversable RT?	N/A
N/A	Landing Length (in)	N/A	N/A	DWS Provided?	N/A
N/A	Landing Width (in)	N/A	N/A	DWS Contrast?	N/A
N/A	Landing Slope (%)	N/A	N/A	DWS Length (in)	N/A
N/A	Landing X Slope (%)	N/A	N/A	DWS Full Width?	N/A
N/A	Landing Curb? (Y/N)	N/A	N/A	DWS Offset (in)	N/A
N/A	Shared Landing?	N/A			
N/A	Gutter Ponding?	N/A	N/A	Gutter Slope (%)	N/A
N/A	Gutter Lip Ht (in)	N/A	N/A	Gutter X Slope (%)	N/A
N/A	Painted X Walk1?	No	N/A	Painted X Walk2?	No
	X Walk 1 Direction	To SE		X Walk 2 Direction	To NE
N/A	X Walk 1 Width (in)	N/A	N/A	X Walk 2 Width (in)	N/A
	X Walk 1 Slope (%)	7.5		X Walk 2 Slope (%)	3.6
	X Walk 1 X Slope (%)	0.1		X Walk 2 X Slope (%)	6.3

N/A	Ramp inside XWalk1?	N/A	N/A	Ramp inside XWalk2?	N/A
	Road Slope (%)	3.5	N/A	Clear Space?	N/A
	Road X Slope (%)	3.7	N/A	Clear Space to XWalk (in)	N/A
N/A	Any Obstructions?	N/A	N/A	Storm Grate/Utility Hazard?	N/A
	Obstruction Type			Storm Grate/Utility Type	
		N/A			N/A
			Yes	Surface Condition? (G/P)	Good

Remove & Replace Curb Ramp With Two New Directional Ramps or Equivalent.
