# Access Compliance Report

## Public Rights-of-Way

### (Curb Ramps)

| Intersection ID: 45784 | Main Street: CRABAPPLE_TREE_LN | Cross Street: LONG_HILL_DR | Location: S |

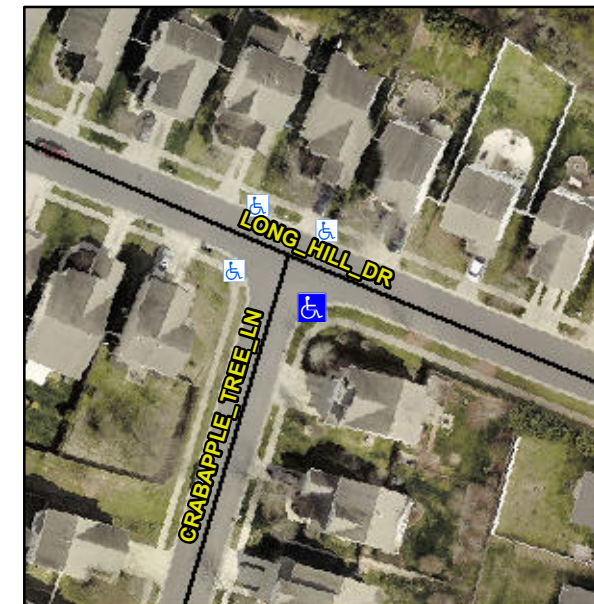
**Not Found, R304.5.1, R304.2.2, R304.5.3**

| Compliance | Description | Data | Compliance | Description | Data |
|---|---|---|---|---|---|
| N/A | Ramp Length (in) | 71.5 | No | Ramp Slope (%) | 9.0 |
| No | Ramp Width (in) | 30.0 | No | Ramp XSlope (%) | 6.0 |

**Remove & Replace Curb Ramp With Two New Directional Ramps or Equivalent.**

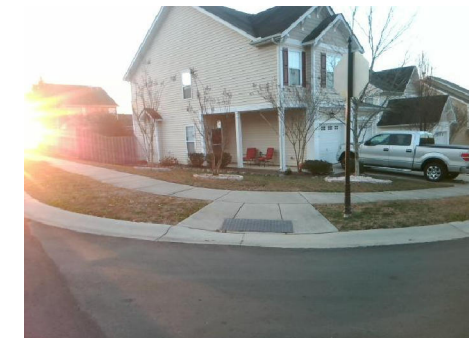
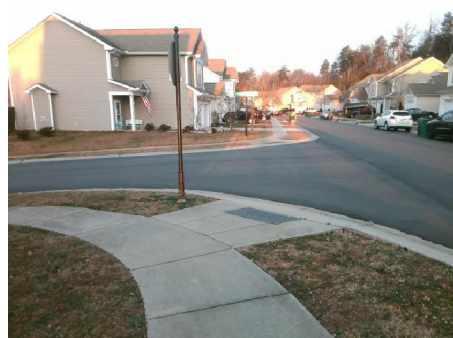
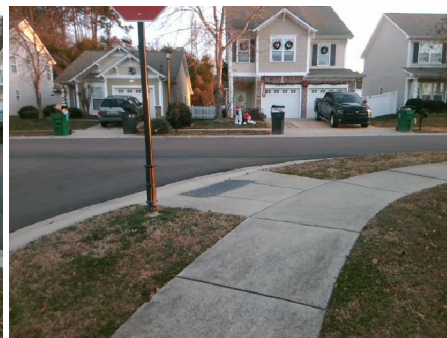
| Compliance | Description | Data | Compliance | Description | Data |
|---|---|---|---|---|---|
| | | | Yes | Surface Condition? (G/P) | Good |
