Access Compliance Report

Public Rights-of-Way

(Curb Ramps)

Intersection ID: 14946	Main Street: DILWORTH_RD_WEST	Cross Street: E WORTHINGTON AV	Location: S
ADA ID: 343A66869025	Ramp Type: Perp	Initial Pass/Fail: Fail	Overall Compliance: No
Severity Score: 26.25			
Codes/Mitigation Info/Possible Solution		Field Measurements/Component Compliance

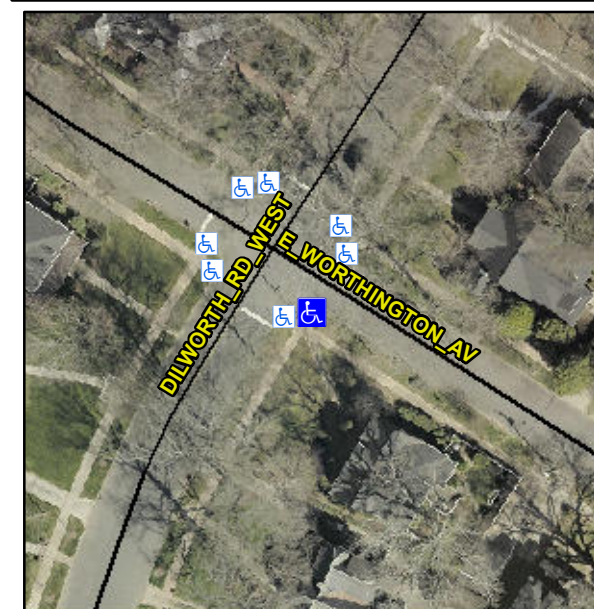
Not Found, R304.2.2, R304.5.3

Compliance	Description	Data	Compliance	Description	Data
N/A	Ramp Length (in)	49.0	No	Ramp Slope (%)	12.6
Yes	Ramp Width (in)	48.0	No	Ramp XSlope (%)	3.2
N/A	Flare Type LT	N/A	N/A	Flare Type RT	N/A
N/A	Flare Slope LT (%)	N/A	N/A	Flare Slope RT (%)	N/A
N/A	Flare Traversable LT?	N/A	N/A	Flare Traversable RT?	N/A
N/A	Landing Length (in)	N/A	N/A	DWS Provided?	N/A
N/A	Landing Width (in)	N/A	N/A	DWS Contrast?	N/A
N/A	Landing Slope (%)	N/A	N/A	DWS Length (in)	N/A
N/A	Landing X Slope (%)	N/A	N/A	DWS Full Width?	N/A
N/A	Landing Curb? (Y/N)	N/A	N/A	DWS Offset (in)	N/A
N/A	Shared Landing?	N/A			
N/A	Gutter Ponding?	Yes	N/A	Gutter Slope (%)	N/A
N/A	Gutter Lip Ht (in)	N/A	N/A	Gutter X Slope (%)	N/A
N/A	Painted X Walk1?	No	N/A	Painted X Walk2?	N/A
	X Walk 1 Direction	To NE		X Walk 2 Direction	N/A
N/A	X Walk 1 Width (in)	N/A	N/A	X Walk 2 Width (in)	N/A
	X Walk 1 Slope (%)	5.2		X Walk 2 Slope (%)	N/A
	X Walk 1 X Slope (%)	1.9		X Walk 2 X Slope (%)	N/A

N/A	Ramp inside XWalk1?	N/A	N/A	Ramp inside XWalk2?	N/A
	Road Slope (%)	N/A	N/A	Clear Space?	N/A
	Road X Slope (%)	N/A	N/A	Clear Space to XWalk (in)	N/A
N/A	Any Obstructions?	N/A	N/A	Storm Grate/Utility Hazard?	N/A
	Obstruction Type			Storm Grate/Utility Type	
		N/A			N/A
		Yes		Surface Condition? (G/P)	Good

Possible Solutions:

Remove & Replace Entire Ramp.
