Access Compliance Report

Public Rights-of-Way

(Curb Ramps)

Intersection ID: N/A	Main Street: NEW_FASHION_WY	Cross Street: N/A	Location: SW
ADA ID: 343DFC5033FA	Ramp Type: Perp	Initial Pass/Fail: Fail	Overall Compliance: No
Severity Score: 33.75			
Codes/Mitigation Info/Possible Solution		Field Measurements/Component Compliance

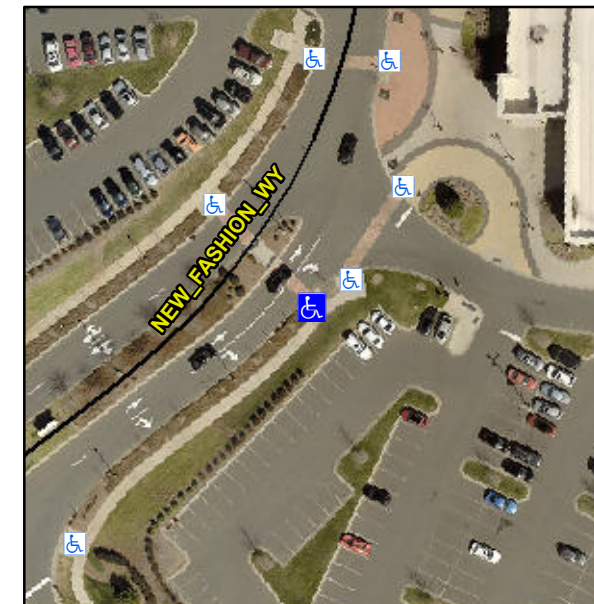
Compliance	Description	Data	Compliance	Description	Data
N/A	Ramp Length (in)	87.0	Yes	Ramp Slope (%)	5.2
No	Ramp Width (in)	47.5	No	Ramp XSlope (%)	9.3
N/A	Flare Type LT	N/A	N/A	Flare Type RT	N/A
N/A	Flare Slope LT (%)	N/A	N/A	Flare Slope RT (%)	N/A
N/A	Flare Traversable LT?	N/A	N/A	Flare Traversable RT?	N/A
N/A	Landing Length (in)	N/A	N/A	DWS Provided?	N/A
N/A	Landing Width (in)	N/A	N/A	DWS Contrast?	N/A
N/A	Landing Slope (%)	N/A	N/A	DWS Length (in)	N/A
N/A	Landing X Slope (%)	N/A	N/A	DWS Full Width?	N/A
N/A	Landing Curb? (Y/N)	N/A	N/A	DWS Offset (in)	N/A
N/A	Shared Landing?	N/A			
N/A	Gutter Ponding?	N/A	N/A	Gutter Slope (%)	N/A
N/A	Gutter Lip Ht (in)	N/A	N/A	Gutter X Slope (%)	N/A
N/A	Painted X Walk1?	Yes	N/A	Painted X Walk2?	N/A
	X Walk 1 Direction	To NW		X Walk 2 Direction	N/A
N/A	X Walk 1 Width (in)	80.0	N/A	X Walk 2 Width (in)	N/A
	X Walk 1 Slope (%)	4.8		X Walk 2 Slope (%)	N/A
	X Walk 1 X Slope (%)	9.2		X Walk 2 X Slope (%)	N/A

Possible Solutions:

Remove & Replace Entire Ramp.
