Access Compliance Report

Public Rights-of-Way

(Curb Ramps)

Intersection ID: 27236	Main Street: BALLANTYNE CORPORATE PL	Cross Street: BRIXHAM HILL AV	Location: W
ADA ID: 344C7D927F75	Ramp Type: Perp	Initial Pass/Fail: Fail	Overall Compliance: No
		Severity Score: 1.25	
Codes/Mitigation Info/Possible Solution		Field Measurements/Component Compliance

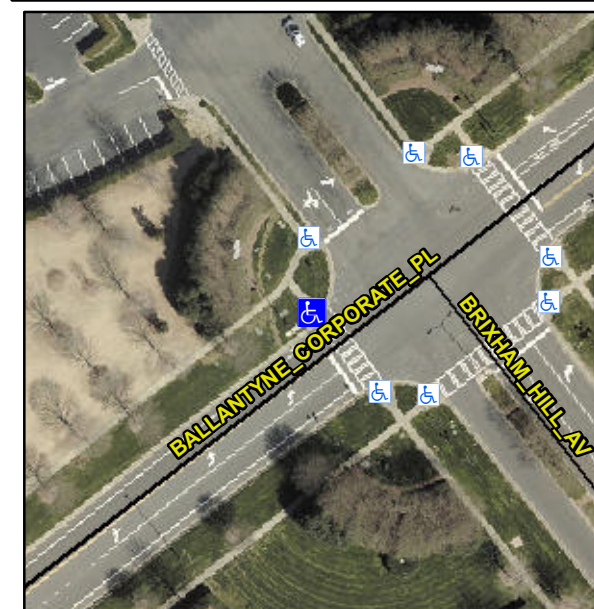
PROW/ADA:

Not Found, R304.5.3

Compliance	Description	Data	Compliance	Description	Data
N/A	Ramp Length (in)	60.0	Yes	Ramp Slope (%)	6.6
Yes	Ramp Width (in)	48.0	No	Ramp XSlope (%)	3.1
N/A	Flare Type LT	N/A	N/A	Flare Type RT	N/A
N/A	Flare Slope LT (%)	N/A	N/A	Flare Slope RT (%)	N/A
N/A	Flare Traversable LT?	N/A	N/A	Flare Traversable RT?	N/A
N/A	Landing Length (in)	N/A	N/A	DWS Provided?	N/A
N/A	Landing Width (in)	N/A	N/A	DWS Contrast?	N/A
N/A	Landing Slope (%)	N/A	N/A	DWS Length (in)	N/A
N/A	Landing X Slope (%)	N/A	N/A	DWS Full Width?	N/A
N/A	Landing Curb? (Y/N)	N/A	N/A	DWS Offset (in)	N/A
N/A	Shared Landing?	N/A			
N/A	Gutter Ponding?	N/A	N/A	Gutter Slope (%)	N/A
N/A	Gutter Lip Ht (in)	N/A	N/A	Gutter X Slope (%)	N/A
N/A	Painted X Walk1?	Yes	N/A	Painted X Walk2?	N/A
	X Walk 1 Direction	To SE		X Walk 2 Direction	N/A
N/A	X Walk 1 Width (in)	110.0	N/A	X Walk 2 Width (in)	N/A
	X Walk 1 Slope (%)	2.8		X Walk 2 Slope (%)	N/A
	X Walk 1 X Slope (%)	2.2		X Walk 2 X Slope (%)	N/A

N/A	Ramp inside XWalk1?	Yes	N/A	Ramp inside XWalk2?	N/A
	Road Slope (%)	N/A	N/A	Clear Space?	N/A
	Road X Slope (%)	N/A	N/A	Clear Space to XWalk (in)	N/A
N/A	Any Obstructions?	N/A	N/A	Storm Grate/Utility Hazard?	N/A
	Obstruction Type			Storm Grate/Utility Type	
		N/A			N/A
			Yes	Surface Condition? (G/P)	Good

Possible Solutions:

Remove & Replace Entire Ramp.

Total Cost: \$ 1850.00
