Access Compliance Report

Public Rights-of-Way

(Curb Ramps)

| Intersection ID: 50599 | Main Street: HEARTLEAF_RD | Cross Street: STREAM_ORCHID_LN | Location: SW |

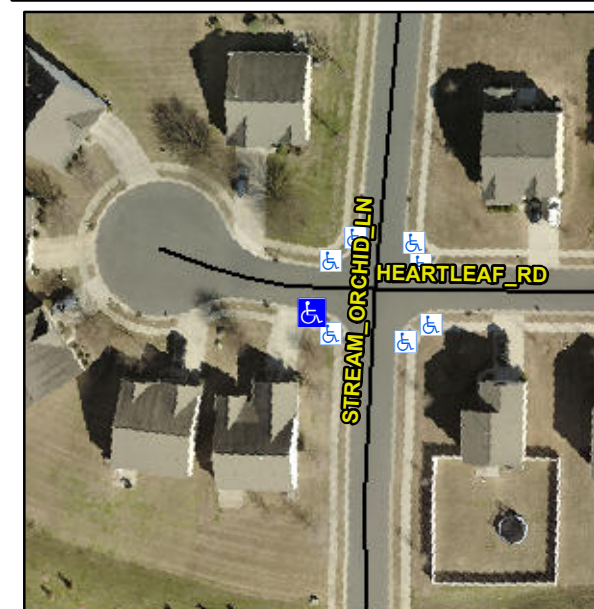
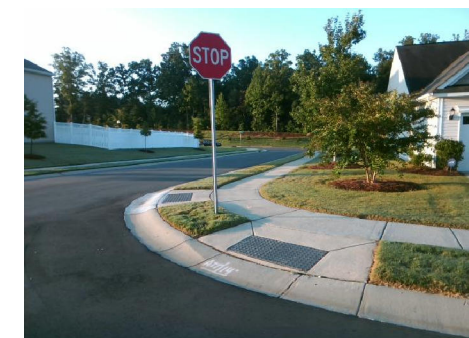
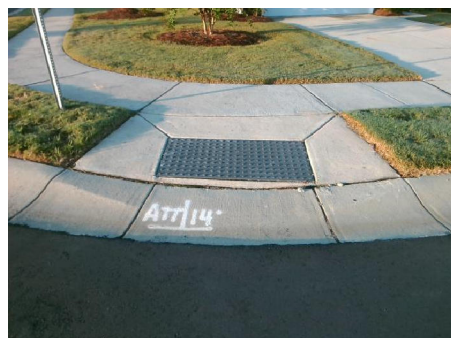
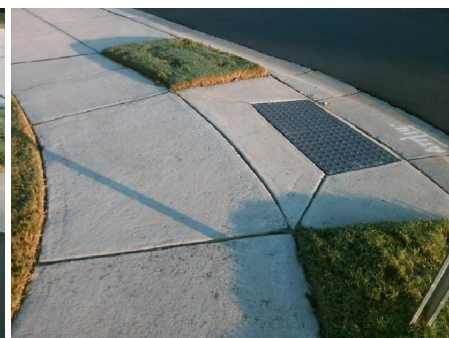
| ADA ID: 345DCBB3523B | Ramp Type: Perp | Initial Pass/Fail: Fail | Overall Compliance: No |
| Severity Score: 26.25 | | | |

Not Found, R304.2.2, R304.5.3

| Compliance | Description | Data | Compliance | Description | Data |
|---|---|---|---|---|---|
| N/A | Ramp Length (in) | 47.5 | No | Ramp Slope (%) | 15.8 |
| Yes | Ramp Width (in) | 48.0 | No | Ramp XSlope (%) | 2.4 |

Remove & Replace Entire Ramp.

Total Cost: \$ 1850.00
