Access Compliance Report

Public Rights-of-Way

(Curb Ramps)

Intersection ID: 54260	Main Street: BALLANTYNE COMMONS PY	Cross Street: BLACK FOREST LN	Location:	S
ADA ID: 34600B28FB40	Ramp Type: Perp	Initial Pass/Fail: Fail	Overall Compliance: No	Severity Score: 25
Codes/Mitigation Info/Possible Solution		Field Measurements/Component Compliance

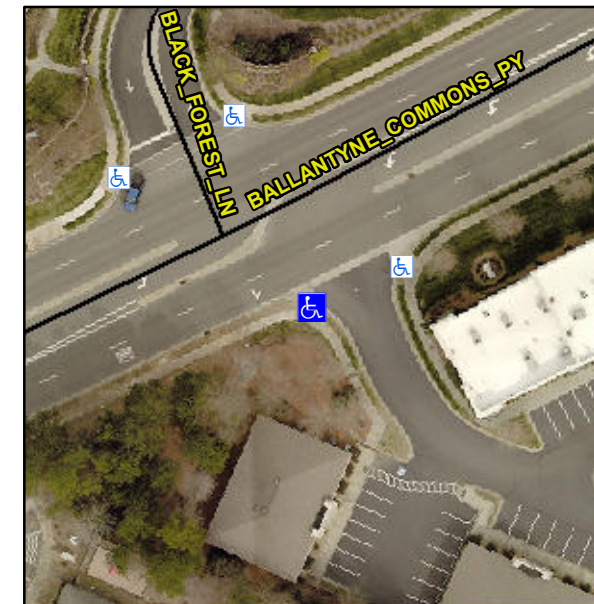
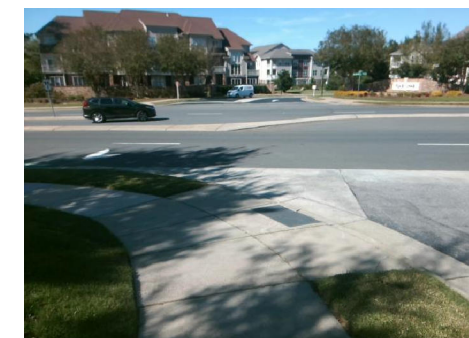
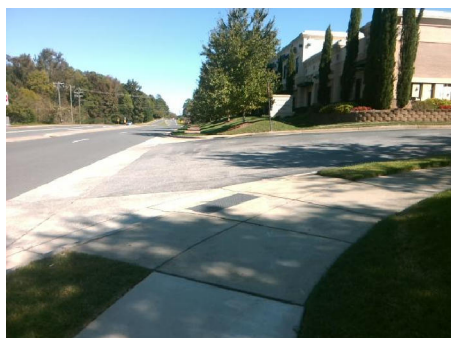
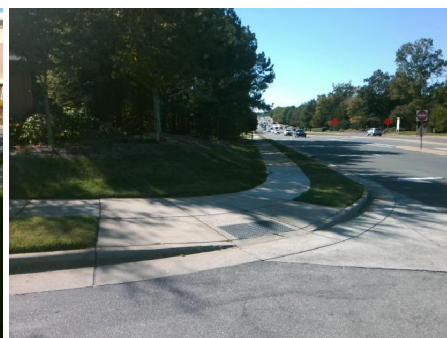
Not Found, R304.5.3

Compliance	Description	Data	Compliance	Description	Data
N/A	Ramp Length (in)	51.0	Yes	Ramp Slope (%)	7.0
Yes	Ramp Width (in)	49.0	No	Ramp XSlope (%)	11.1
N/A	Flare Type LT	N/A	N/A	Flare Type RT	N/A
N/A	Flare Slope LT (%)	N/A	N/A	Flare Slope RT (%)	N/A
N/A	Flare Traversable LT?	N/A	N/A	Flare Traversable RT?	N/A
N/A	Landing Length (in)	N/A	N/A	DWS Provided?	N/A
N/A	Landing Width (in)	N/A	N/A	DWS Contrast?	N/A
N/A	Landing Slope (%)	N/A	N/A	DWS Length (in)	N/A
N/A	Landing X Slope (%)	N/A	N/A	DWS Full Width?	N/A
N/A	Landing Curb? (Y/N)	N/A	N/A	DWS Offset (in)	N/A
N/A	Shared Landing?	N/A			
N/A	Gutter Ponding?	N/A	N/A	Gutter Slope (%)	N/A
N/A	Gutter Lip Ht (in)	N/A	N/A	Gutter X Slope (%)	N/A
N/A	Painted X Walk1?	No	N/A	Painted X Walk2?	N/A
	X Walk 1 Direction	To E		X Walk 2 Direction	N/A
N/A	X Walk 1 Width (in)	N/A	N/A	X Walk 2 Width (in)	N/A
	X Walk 1 Slope (%)	4.2		X Walk 2 Slope (%)	N/A
	X Walk 1 X Slope (%)	7.7		X Walk 2 X Slope (%)	N/A

N/A	Ramp inside XWalk1?	N/A	N/A	Ramp inside XWalk2?	N/A
	Road Slope (%)	N/A	N/A	Clear Space?	N/A
	Road X Slope (%)	N/A	N/A	Clear Space to XWalk (in)	N/A
N/A	Any Obstructions?	N/A	N/A	Storm Grate/Utility Hazard?	N/A
	Obstruction Type			Storm Grate/Utility Type	
		N/A			N/A
			Yes	Surface Condition? (G/P)	Good

Remove & Replace Entire Ramp.

Total Cost: \$ 1850.00
