Access Compliance Report

Public Rights-of-Way

(Curb Ramps)

Intersection ID: N/A	Main Street: PIMA_COTTON_DR	Cross Street: KANFER_CT	Location: SW
ADA ID: 346A0C53E13C	Ramp Type: BlendTrans2	Initial Pass/Fail: Pass	Overall Compliance: No
Codes/Mitigation Info/Possible Solution		Field Measurements/Component Compliance	
Severity Score: 10.25

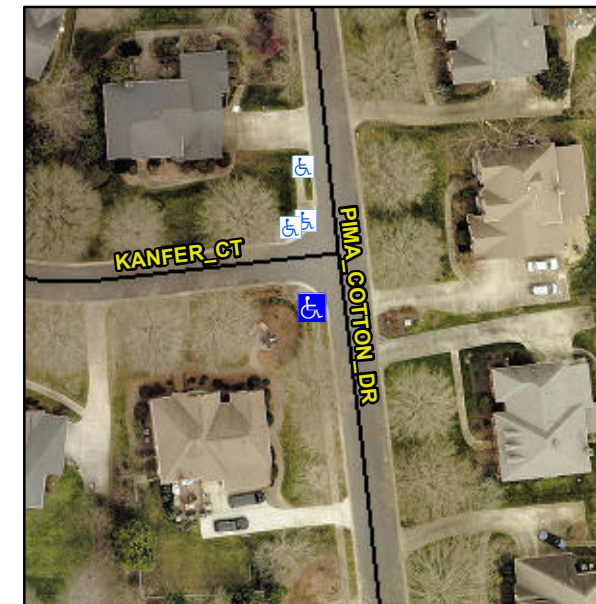
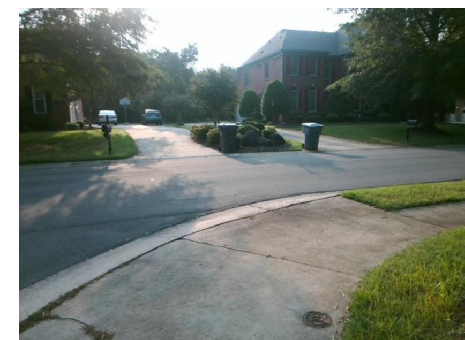
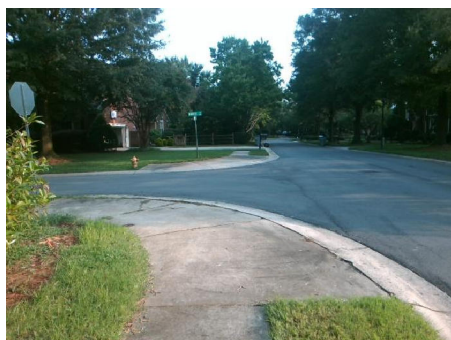
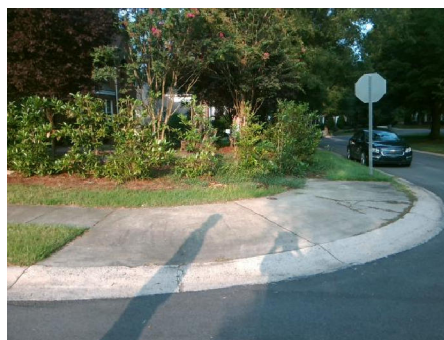
Compliance	Description	Data	Compliance	Description	Data
N/A	Ramp Length (in)	97.0	Yes	BlendTrans Slope (%)	3.3
Yes	Ramp Width (in)	48.0	No	BlendTrans XSlope (%)	3.3
N/A	Flare Type LT	None	N/A	Flare Type RT	None
N/A	Flare Slope LT (%)	N/A	N/A	Flare Slope RT (%)	N/A
N/A	Flare Traversable LT?	N/A	N/A	Flare Traversable RT?	N/A
N/A	Landing Length (in)	N/A	No	DWS Provided?	No
N/A	Landing Width (in)	N/A	N/A	DWS Contrast?	No
N/A	Landing Slope (%)	N/A	N/A	DWS Length (in)	N/A
N/A	Landing X Slope (%)	N/A	N/A	DWS Full Width?	No
N/A	Landing Curb? (Y/N)	No	N/A	DWS Offset (in)	N/A
N/A	Shared Landing?	No			
Yes	Gutter Ponding?	No	Yes	Gutter Slope (%)	0.1
Yes	Gutter Lip Ht (in)	0.0	Yes	Gutter X Slope (%)	0.6
N/A	Painted X Walk1?	No	N/A	Painted X Walk2?	No
	X Walk 1 Direction	To E		X Walk 2 Direction	To N
	X Walk 1 Width (in)	N/A		X Walk 2 Width (in)	N/A
	X Walk 1 Slope (%)	0.5		X Walk 2 Slope (%)	0.9
	X Walk 1 X Slope (%)	0.3		X Walk 2 X Slope (%)	3.9

N/A	Ramp inside XWalk1?	N/A	N/A	Ramp inside XWalk2?	N/A
	Road Slope (%)	0.1		Clear Space?	Yes
	Road X Slope (%)	3.2	N/A	Clear Space to XWalk (in)	N/A
Yes	Any Obstructions?	No	Yes	Storm Grate/Utility Hazard?	No
	Obstruction Type			Storm Grate/Utility Type	
		N/A			N/A
			Yes	Surface Condition? (G/P)	Good
			N/A	Curb Slope (%)	2.9

Remove & Replace Curb Ramp With Two New Directional Ramps or Equivalent.

R304.5.3, R305
