| Intersection ID: 10021176 | Main Street: BILLINGSLEY_RD | Cross Street: N/A | Location: | NE |
| ADA ID: 346D50E33ED7 | Ramp Type: PerpDiag | Initial Pass/Fail: Fail | Overall Compliance: No | Severity Score: 1.25 |

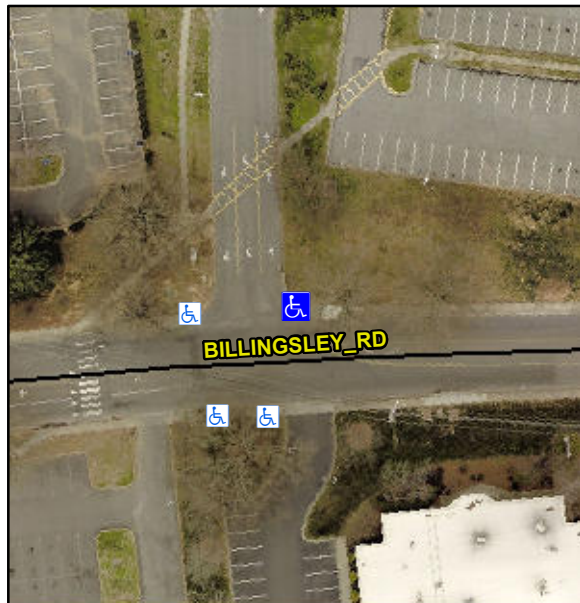
### R304.5.3

| Compliance | Description | Data | Compliance | Description | Data |
|---|---|---|---|---|---|
| N/A | Ramp Length (in) | 40.0 | Yes | Ramp Slope (%) | 5.1 |
| Yes | Ramp Width (in) | 48.0 | No | Ramp XSlope (%) | 3.4 |

**Remove & Replace Curb Ramp With Two New Directional Ramps or Equivalent.**

Total Cost: \$ 3200.00
