Access Compliance Report

Public Rights-of-Way

(Curb Ramps)

Intersection ID: 10829	Main Street: E_34TH_ST	Cross Street: HOLT_ST	Location: W
ADA ID: 3479C0353D3A	Ramp Type: PerpDiag	Initial Pass/Fail: Fail	Overall Compliance: No
		Severity Score: 12.5

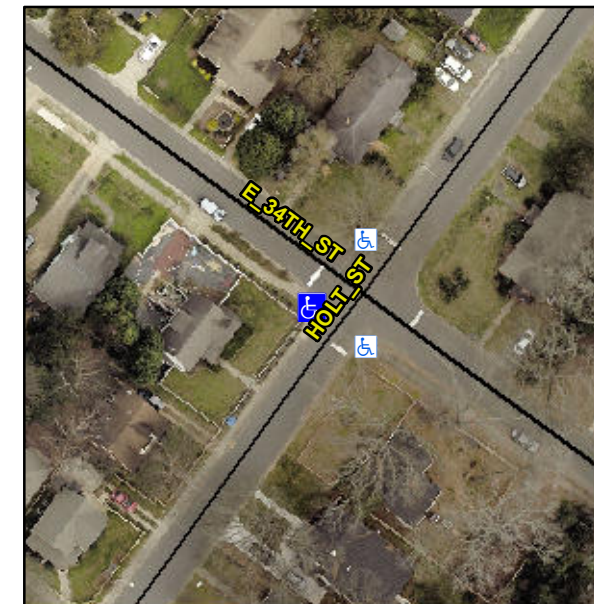
Not Found, R304.2.2

Compliance	Description	Data	Compliance	Description	Data
N/A	Ramp Length (in)	54.5	No	Ramp Slope (%)	9.1
Yes	Ramp Width (in)	48.0	Yes	Ramp XSlope (%)	1.8
N/A	Flare Type LT	N/A	N/A	Flare Type RT	N/A
N/A	Flare Slope LT (%)	N/A	N/A	Flare Slope RT (%)	N/A
N/A	Flare Traversable LT?	N/A	N/A	Flare Traversable RT?	N/A
N/A	Landing Length (in)	N/A	N/A	DWS Provided?	N/A
N/A	Landing Width (in)	N/A	N/A	DWS Contrast?	N/A
N/A	Landing Slope (%)	N/A	N/A	DWS Length (in)	N/A
N/A	Landing X Slope (%)	N/A	N/A	DWS Full Width?	N/A
N/A	Landing Curb? (Y/N)	N/A	N/A	DWS Offset (in)	N/A
N/A	Shared Landing?	N/A			
N/A	Gutter Ponding?	N/A	N/A	Gutter Slope (%)	N/A
N/A	Gutter Lip Ht (in)	N/A	N/A	Gutter X Slope (%)	N/A
N/A	Painted X Walk1?	No	N/A	Painted X Walk2?	No
	X Walk 1 Direction	To SE		X Walk 2 Direction	To NE
N/A	X Walk 1 Width (in)	N/A	N/A	X Walk 2 Width (in)	N/A
	X Walk 1 Slope (%)	5.0		X Walk 2 Slope (%)	0.3
	X Walk 1 X Slope (%)	2.4		X Walk 2 X Slope (%)	3.2

N/A	Ramp inside XWalk1?	N/A	N/A	Ramp inside XWalk2?	N/A
	Road Slope (%)	4.8	N/A	Clear Space?	N/A
	Road X Slope (%)	5.6	N/A	Clear Space to XWalk (in)	N/A
N/A	Any Obstructions?	N/A	N/A	Storm Grate/Utility Hazard?	N/A
	Obstruction Type			Storm Grate/Utility Type	
		N/A			N/A
			Yes	Surface Condition? (G/P)	Good

Remove & Replace Curb Ramp With Two New Directional Ramps or Equivalent.

Total Cost: \$ 3200.00
