# Access Compliance Report

## Public Rights-of-Way

### (Curb Ramps)

Intersection ID: 11841	Main Street: E_18TH_ST	Cross Street: HARRILL_ST	Location: W
ADA ID: 347A25955A64	Ramp Type: Directional1	Initial Pass/Fail: Fail	Overall Compliance: No
		Severity Score: 12.5

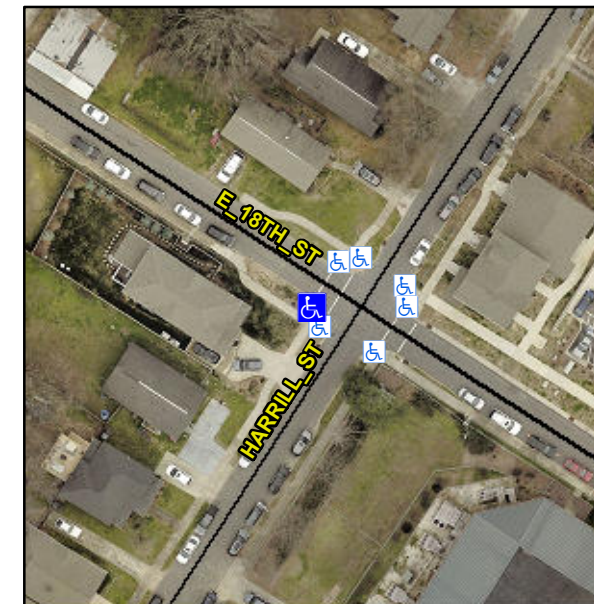
Compliance	Description	Data	Compliance	Description	Data
N/A	Ramp Length (in)	75.0	N/A	Grade Break?	N/A
Yes	Ramp Width (in)	54.5	N/A	Grade Break Slope (%)	0.0
No	Ramp Slope (%)	8.4	N/A	Grade Break XSlope (%)	0.0
Yes	Ramp XSlope (%)	0.3			
N/A	Flare Type LT	N/A	N/A	Flare Type RT	N/A
N/A	Flare Slope LT (%)	N/A	N/A	Flare Slope RT (%)	0.0
N/A	Flare Traversable LT?	N/A	N/A	Flare Traversable RT?	N/A
N/A	Landing Length (in)	0.0	N/A	DWS Provided?	N/A
N/A	Landing Width (in)	0.0	N/A	DWS Contrast?	N/A
N/A	Landing Slope (%)	0.0	N/A	DWS Length (in)	N/A
N/A	Landing X Slope (%)	0.0	N/A	DWS Full Width?	N/A
N/A	Landing Curb? (Y/N)	N/A	N/A	DWS Offset LT (in)	N/A
N/A	Shared Landing?	N/A	N/A	DWS Offset RT (in)	N/A
N/A	Gutter Ponding?	0.0	N/A	Gutter Slope (%)	N/A
N/A	Gutter Lip Ht (in)	0.0	N/A	Gutter X Slope (%)	N/A
N/A	Painted X Walk1?	No		Road Slope (%)	3.5
	X Walk 1 Direction	To NE		Road X Slope (%)	1.9
	X Walk 1 Width (in)	N/A		Clear Space?	N/A

X Walk 1 Slope (%)	3.5	N/A	Clear Space to XWalk (in)	N/A
	X Walk 1 X Slope (%)	1.9	N/A	Storm Grate/Utility Hazard?	N/A
N/A	Ramp inside XWalk1?	N/A		Storm Grate/Utility Type	
N/A	Any Obstructions?	N/A			N/A
	Obstruction Type		Yes	Surface Condition? (G/P)	Good
			N/A	Curb Slope (%)	12.5

**Remove & Replace Entire Ramp.**

**R304.2.2**

\$ 1600.00
