## Access Compliance Report Public Rights-of-Way (Curb Ramps)

Intersection ID: 12594	594 Main Street: REMOUNT_RD		Cross	Street:	WILKINSON_BV	Location:	NE		
ADA ID: 347ED1C0B72D	: 347ED1C0B72D Ramp Type: PerpDiag			nitial Pass/Fail: Fail Overall Compliance: No				o Severity Score:	33.75
Codes/Mitigation Info/Possible Solution				Field Measurements/Component Compliance					
	A	Possible Solutions:		Compliance Description		Data	Data Compliance Description		Data
32 6		Remove & Replace Curb Ramp \	Nith	N/A	Ramp Length (in)	60.0	No	Ramp Slope (%)	9.6
		Two New Directional Ramps or Equivalent.		No	Ramp Width (in)	46.0	No	Ramp XSlope (%)	5.9
STR BELL				N/A	Flare Type LT	N/A	N/A	Flare Type RT	N/A
				N/A	Flare Slope LT (%)	N/A	N/A	Flare Slope RT (%)	N/A
	Allerer			N/A	Flare Traversable LT?	N/A	N/A	Flare Traversable RT?	N/A
				N/A	Landing Length (in)	N/A	N/A	DWS Provided?	N/A
ANNO AND		Surveyor Notes:		N/A	Landing Width (in)	N/A	N/A	DWS Contrast?	N/A
		N/A		N/A	Landing Slope (%)	N/A	N/A	DWS Length (in)	N/A

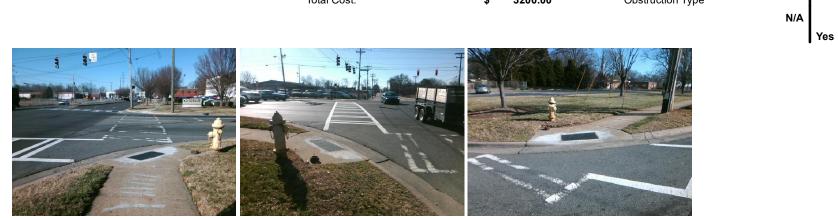
3			N/A	Landing X Slope (%)	N/A	N/A	DWS Full Width?	N/A
WILLKINSON_EV				N/A	Landing Curb? (Y/N)	N/A	N/A	DWS Offset (in)	N/A
				N/A	Shared Landing?	N/A			
	1 21 2 2	PROW/ADA:		N/A	Gutter Ponding?	N/A	N/A	Gutter Slope (%)	N/A
Not Found, R304.5.1, R304.2.2, R304.5.3				N/A	Gutter Lip Ht (in)	N/A	N/A	Gutter X Slope (%)	N/A
				N/A	Painted X Walk1?	No	N/A	Painted X Walk2?	Yes
					X Walk 1 Direction	To W		X Walk 2 Direction	To S
				N/A	X Walk 1 Width (in)	N/A	N/A	X Walk 2 Width (in)	95.0
Street 1 Name	REMOUNT RD				X Walk 1 Slope (%)	0.5		X Walk 2 Slope (%)	7.7
Stop Condition-Street 2	Signal				X Walk 1 X Slope (%)	6.4		X Walk 2 X Slope (%)	0.9
Street 2 Name	WILKINSON BV			N/A	Ramp inside XWalk1?	N/A	N/A	Ramp inside XWalk2?	Yes
Stop Condition-Street 1	Signal				Road Slope (%)	5.3	N/A	Clear Space?	N/A
					Road X Slope (%)	3.2	N/A	Clear Space to XWalk (in)	N/A
				N/A	Any Obstructions?	N/A	N/A	Storm Grate/Utility Hazard?	N/A

Total Cost: \$	3200.00		Obstruction Type			Storm Grate/Utility Type	
						N/A			N/A
