Access Compliance Report

Public Rights-of-Way

(Curb Ramps)

Intersection ID: 15070	Main Street: IDEAL_WY	Cross Street: REMOUNT_RD	Location: SW
ADA ID: 347FEBB556AC	Ramp Type: Perp	Initial Pass/Fail: Fail	Overall Compliance: No
Severity Score: 22.5			
Codes/Mitigation Info/Possible Solution		Field Measurements/Component Compliance

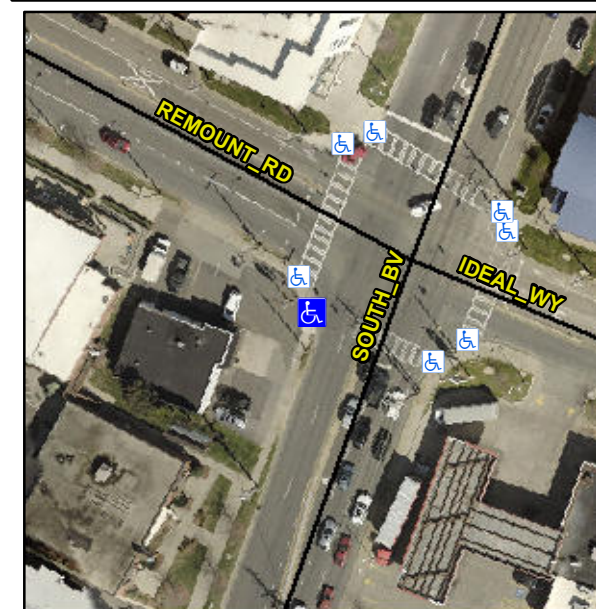
Not Found, R304.5.1, R304.2.2, R304.5.3

Compliance	Description	Data	Compliance	Description	Data
N/A	Ramp Length (in)	72.0	No	Ramp Slope (%)	9.6
No	Ramp Width (in)	47.5	No	Ramp XSlope (%)	3.5
N/A	Flare Type LT	N/A	N/A	Flare Type RT	N/A
N/A	Flare Slope LT (%)	N/A	N/A	Flare Slope RT (%)	N/A
N/A	Flare Traversable LT?	N/A	N/A	Flare Traversable RT?	N/A
N/A	Landing Length (in)	N/A	N/A	DWS Provided?	N/A
N/A	Landing Width (in)	N/A	N/A	DWS Contrast?	N/A
N/A	Landing Slope (%)	N/A	N/A	DWS Length (in)	N/A
N/A	Landing X Slope (%)	N/A	N/A	DWS Full Width?	N/A
N/A	Landing Curb? (Y/N)	N/A	N/A	DWS Offset (in)	N/A
N/A	Shared Landing?	N/A			
N/A	Gutter Ponding?	N/A	N/A	Gutter Slope (%)	N/A
N/A	Gutter Lip Ht (in)	N/A	N/A	Gutter X Slope (%)	N/A
N/A	Painted X Walk1?	Yes	N/A	Painted X Walk2?	N/A
	X Walk 1 Direction	To SE		X Walk 2 Direction	N/A
N/A	X Walk 1 Width (in)	98.0	N/A	X Walk 2 Width (in)	N/A
	X Walk 1 Slope (%)	1.6		X Walk 2 Slope (%)	N/A
	X Walk 1 X Slope (%)	3.0		X Walk 2 X Slope (%)	N/A

N/A	Ramp inside XWalk1?	Yes	N/A	Ramp inside XWalk2?	N/A
	Road Slope (%)	N/A	N/A	Clear Space?	N/A
	Road X Slope (%)	N/A	N/A	Clear Space to XWalk (in)	N/A
N/A	Any Obstructions?	N/A	N/A	Storm Grate/Utility Hazard?	N/A
	Obstruction Type			Storm Grate/Utility Type	
		N/A			N/A
			Yes	Surface Condition? (G/P)	Good

Possible Solutions:

Remove & Replace Entire Ramp.
