# Access Compliance Report

## Public Rights-of-Way

### (Curb Ramps)

| Intersection ID: 15238 | Main Street: CLANTON_RD | Cross Street: MANCHESTER_DR | Location: NW |

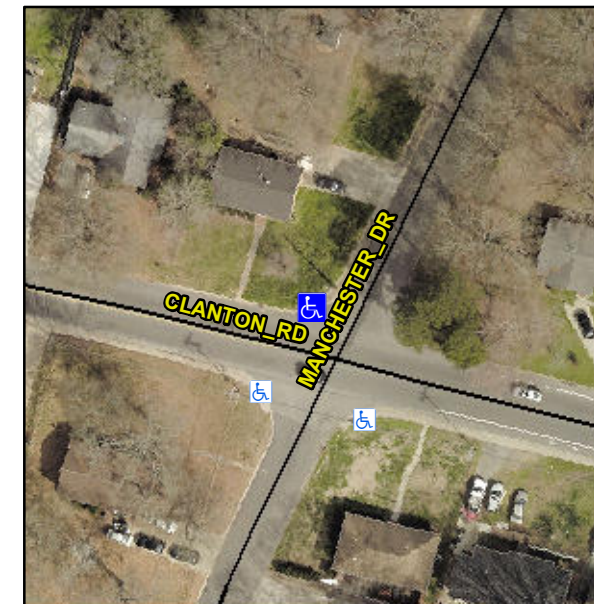
| ADA ID: 34972A76395D | Ramp Type: PerpDiag | Initial Pass/Fail: Fail | Overall Compliance: No |
| | | Severity Score: 10 | |

**Not Found, R304.5.1, R304.5.3**

| Compliance | Description | Data | Compliance | Description | Data |
|---|---|---|---|---|---|
| N/A | Ramp Length (in) | 52.0 | Yes | Ramp Slope (%) | 5.3 |
| No | Ramp Width (in) | 45.5 | No | Ramp XSlope (%) | 2.5 |

**Remove & Replace Curb Ramp With Two New Directional Ramps or Equivalent.**

Total Cost: \$ 3200.00
