Access Compliance Report Public Rights-of-Way (Curb Ramps)

Intersection ID: 19204 Main Street: CHARTER_PL Cross Street: ROCKY_FALLS_RD Location: E

ADA ID: 349A050FA0FF Ramp Type: BlendTrans1 Initial Pass/Fail: Fail Overall Compliance: No Severity Score: 8.75

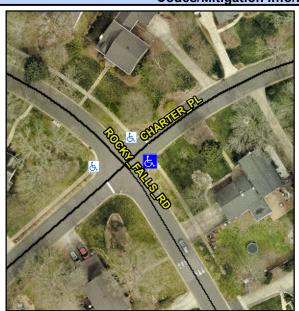
Not Found, R304.5.1

Compliance Description Deta Compliance Description Deta					
Compliance Description		Data	Compliance Description		Data
N/A	Ramp Length (in)	50.0	Yes	BlendTrans Slope (%)	3.9
No	Ramp Width (in)	44.0	Yes	BlendTrans XSlope (%)	0.5
N/A	Flare Type LT	N/A	N/A	Flare Type RT	N/A
N/A	Flare Slope LT (%)	N/A	N/A	Flare Slope RT (%)	N/A
N/A	Flare Traversable LT?	N/A	N/A	Flare Traversable RT?	N/A
N/A	Landing Length (in)	N/A	N/A	DWS Provided?	N/A
N/A	Landing Width (in)	N/A	N/A	DWS Contrast?	N/A
N/A	Landing Slope (%)	N/A	N/A	DWS Length (in)	N/A
N/A	Landing X Slope (%)	N/A	N/A	DWS Full Width?	N/A
N/A	Landing Curb? (Y/N)	N/A	N/A	DWS Offset (in)	N/A
N/A	Shared Landing?	N/A			
N/A	Gutter Ponding?	N/A	N/A	Gutter Slope (%)	N/A
N/A	Gutter Lip Ht (in)	N/A	N/A	Gutter X Slope (%)	N/A
N/A	Painted X Walk1?	No	N/A	Painted X Walk2?	No
	X Walk 1 Direction	To NW		X Walk 2 Direction	To SW
	X Walk 1 Width (in)	N/A		X Walk 2 Width (in)	N/A

X Walk 1 Slope (%)	4.7		X Walk 2 Slope (%)	2.8
	X Walk 1 X Slope (%)	2.9		X Walk 2 X Slope (%)	5.8
N/A	Ramp inside XWalk1?	N/A	N/A	Ramp inside XWalk2?	N/A
	Road Slope (%)	0.2		Clear Space?	N/A
	Road X Slope (%)	5.6	N/A	Clear Space to XWalk (in)	N/A
N/A	Any Obstructions?	N/A	N/A	Storm Grate/Utility Hazard?	N/A
	Obstruction Type			Storm Grate/Utility Type	
		N/A			N/A
			Yes	Surface Condition? (G/P)	Good

(1. 11% J	A STATE OF		No	Curb Slope (%)	7.3

Remove & Replace Curb Ramp With Two New Directional Ramps or Equivalent.
