Access Compliance Report

Public Rights-of-Way

(Curb Ramps)

Intersection ID: 48476	Main Street: FERNLEDGE_CT	Cross Street: AUTUMN_OAK_DR	Location:	N
ADA ID: 349EE72847FA	Ramp Type: PerpDiag	Initial Pass/Fail: Fail	Overall Compliance: No	Severity Score: 35

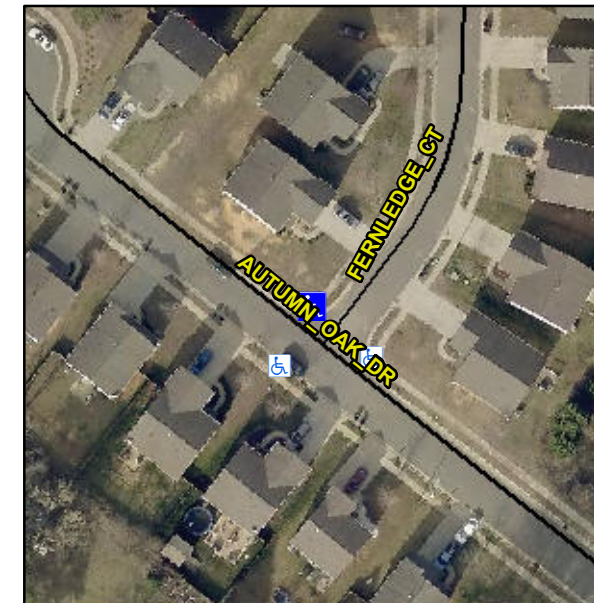
Not Found, R304.5.1, R304.2.2, R304.5.3

Compliance	Description	Data	Compliance	Description	Data
N/A	Ramp Length (in)	50.0	No	Ramp Slope (%)	20.0
No	Ramp Width (in)	47.5	No	Ramp XSlope (%)	2.4
N/A	Flare Type LT	N/A	N/A	Flare Type RT	N/A
N/A	Flare Slope LT (%)	N/A	N/A	Flare Slope RT (%)	N/A
N/A	Flare Traversable LT?	N/A	N/A	Flare Traversable RT?	N/A
N/A	Landing Length (in)	N/A	N/A	DWS Provided?	N/A
N/A	Landing Width (in)	N/A	N/A	DWS Contrast?	N/A
N/A	Landing Slope (%)	N/A	N/A	DWS Length (in)	N/A
N/A	Landing X Slope (%)	N/A	N/A	DWS Full Width?	N/A
N/A	Landing Curb? (Y/N)	N/A	N/A	DWS Offset (in)	N/A
N/A	Shared Landing?	N/A			
N/A	Gutter Ponding?	N/A	N/A	Gutter Slope (%)	N/A
N/A	Gutter Lip Ht (in)	N/A	N/A	Gutter X Slope (%)	N/A
N/A	Painted X Walk1?	No	N/A	Painted X Walk2?	No
	X Walk 1 Direction	To SW		X Walk 2 Direction	To SE
N/A	X Walk 1 Width (in)	N/A	N/A	X Walk 2 Width (in)	N/A
	X Walk 1 Slope (%)	3.0		X Walk 2 Slope (%)	0.5
	X Walk 1 X Slope (%)	1.1		X Walk 2 X Slope (%)	4.0

N/A	Ramp inside XWalk1?	N/A	N/A	Ramp inside XWalk2?	N/A
	Road Slope (%)	3.5	N/A	Clear Space?	N/A
	Road X Slope (%)	3.0	N/A	Clear Space to XWalk (in)	N/A
N/A	Any Obstructions?	N/A	N/A	Storm Grate/Utility Hazard?	N/A
	Obstruction Type			Storm Grate/Utility Type	
		N/A			N/A
			Yes	Surface Condition? (G/P)	Good

Remove & Replace Curb Ramp With Two New Directional Ramps or Equivalent.

Total Cost: \$ 3200.00
