# Access Compliance Report

## Public Rights-of-Way

### (Curb Ramps)

Intersection ID: 10570	Main Street: HERRIN_AV	Cross Street: HOLT_ST	Location: NE
ADA ID: 34A169F8B8E1	Ramp Type: BlendTrans2	Initial Pass/Fail: Fail	Overall Compliance: No
Severity Score: 33.75			
Codes/Mitigation Info/Possible Solution		Field Measurements/Component Compliance

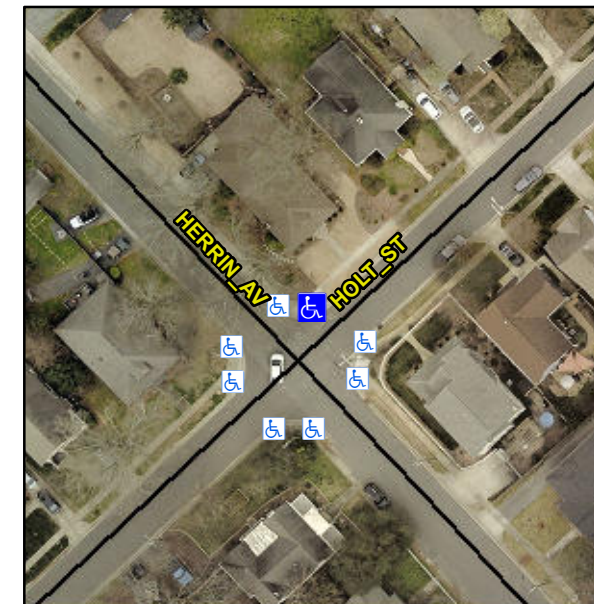
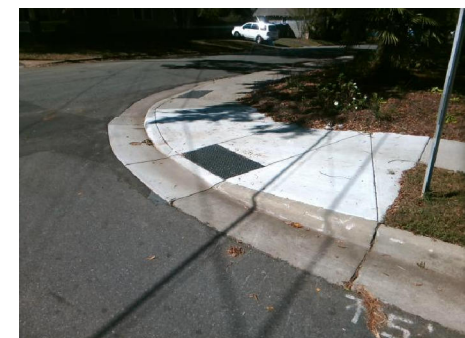
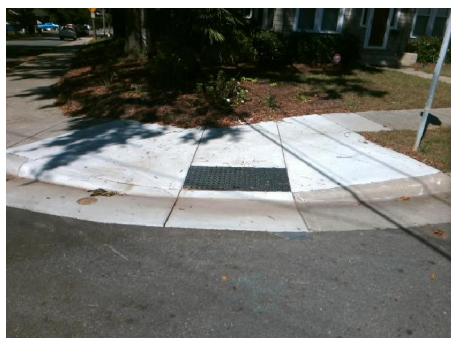
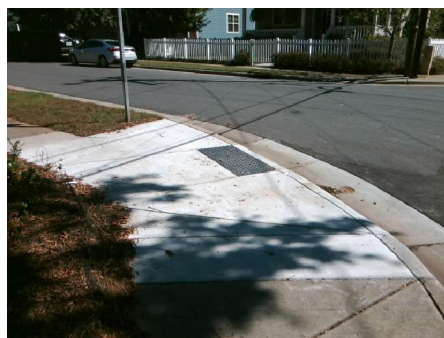
**Not Found, R304.5.1, R304.5.3**

Compliance	Description	Data	Compliance	Description	Data
N/A	Ramp Length (in)	93.0	Yes	BlendTrans Slope (%)	4.7
No	Ramp Width (in)	46.5	No	BlendTrans XSlope (%)	7.7
N/A	Flare Type LT	N/A	N/A	Flare Type RT	N/A
N/A	Flare Slope LT (%)	N/A	N/A	Flare Slope RT (%)	N/A
N/A	Flare Traversable LT?	N/A	N/A	Flare Traversable RT?	N/A
N/A	Landing Length (in)	N/A	N/A	DWS Provided?	N/A
N/A	Landing Width (in)	N/A	N/A	DWS Contrast?	N/A
N/A	Landing Slope (%)	N/A	N/A	DWS Length (in)	N/A
N/A	Landing X Slope (%)	N/A	N/A	DWS Full Width?	N/A
N/A	Landing Curb? (Y/N)	N/A	N/A	DWS Offset (in)	N/A
N/A	Shared Landing?	N/A			
N/A	Gutter Ponding?	N/A	N/A	Gutter Slope (%)	N/A
N/A	Gutter Lip Ht (in)	N/A	N/A	Gutter X Slope (%)	N/A
N/A	Painted X Walk1?	No	N/A	Painted X Walk2?	N/A
	X Walk 1 Direction	To SE		X Walk 2 Direction	N/A
	X Walk 1 Width (in)	N/A		X Walk 2 Width (in)	N/A
	X Walk 1 Slope (%)	2.3		X Walk 2 Slope (%)	N/A
	X Walk 1 X Slope (%)	1.4		X Walk 2 X Slope (%)	N/A

N/A	Ramp inside XWalk1?	N/A	N/A	Ramp inside XWalk2?	N/A
	Road Slope (%)	1.4		Clear Space?	N/A
	Road X Slope (%)	2.3	N/A	Clear Space to XWalk (in)	N/A
N/A	Any Obstructions?	N/A	N/A	Storm Grate/Utility Hazard?	N/A
	Obstruction Type			Storm Grate/Utility Type	
		N/A			N/A
			Yes	Surface Condition? (G/P)	Good
			No	Curb Slope (%)	27.9

**Remove & Replace Curb Ramp With Two New Directional Ramps or Equivalent.**
