# Access Compliance Report

## Public Rights-of-Way

### (Curb Ramps)

| Intersection ID: 23232 | Main Street: PARK_RD | Cross Street: QUAIL_HILL_RD | Location: NW |

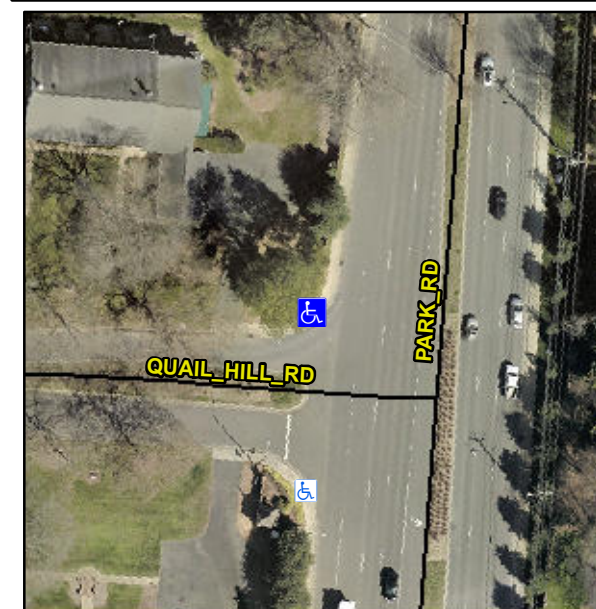
| ADA ID: 34A5CED77574 | Ramp Type: PerpDiag | Initial Pass/Fail: Fail | Overall Compliance: No |
| Severity Score: 12.5 | | | |

**Not Found, R304.2.2**

| Compliance | Description | Data | Compliance | Description | Data |
|---|---|---|---|---|---|
| N/A | Ramp Length (in) | 57.0 | No | Ramp Slope (%) | 11.1 |
| Yes | Ramp Width (in) | 48.0 | Yes | Ramp XSlope (%) | 0.6 |

**Remove & Replace Curb Ramp With Two New Directional Ramps or Equivalent.**

Total Cost: \$ 3200.00
