Access Compliance Report

Public Rights-of-Way

(Curb Ramps)

Intersection ID: 3625	Main Street: SANDRINGHAM_PL	Cross Street: CHOWNING_TAVERN_LN	Location: W
ADA ID: 34BE8EAC1607	Ramp Type: Perp	Initial Pass/Fail: Fail	Overall Compliance: No
Codes/Mitigation Info/Possible Solution		Field Measurements/Component Compliance	
Severity Score: 33.75

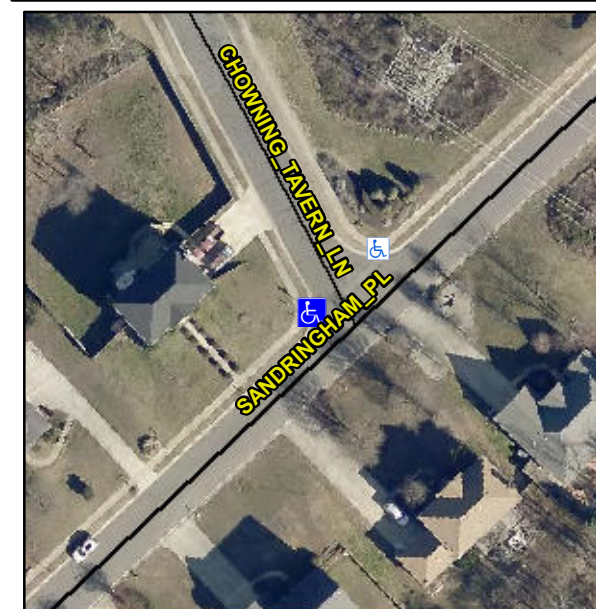
Not Found, R304.5.1, R304.5.3

Compliance	Description	Data	Compliance	Description	Data
N/A	Ramp Length (in)	47.0	Yes	Ramp Slope (%)	5.0
No	Ramp Width (in)	43.5	No	Ramp XSlope (%)	11.1
N/A	Flare Type LT	N/A	N/A	Flare Type RT	N/A
N/A	Flare Slope LT (%)	N/A	N/A	Flare Slope RT (%)	N/A
N/A	Flare Traversable LT?	N/A	N/A	Flare Traversable RT?	N/A
N/A	Landing Length (in)	N/A	N/A	DWS Provided?	N/A
N/A	Landing Width (in)	N/A	N/A	DWS Contrast?	N/A
N/A	Landing Slope (%)	N/A	N/A	DWS Length (in)	N/A
N/A	Landing X Slope (%)	N/A	N/A	DWS Full Width?	N/A
N/A	Landing Curb? (Y/N)	N/A	N/A	DWS Offset (in)	N/A
N/A	Shared Landing?	N/A			
N/A	Gutter Ponding?	N/A	N/A	Gutter Slope (%)	N/A
N/A	Gutter Lip Ht (in)	N/A	N/A	Gutter X Slope (%)	N/A
N/A	Painted X Walk1?	No	N/A	Painted X Walk2?	N/A
	X Walk 1 Direction	To NE		X Walk 2 Direction	N/A
N/A	X Walk 1 Width (in)	N/A	N/A	X Walk 2 Width (in)	N/A
	X Walk 1 Slope (%)	5.0		X Walk 2 Slope (%)	N/A
	X Walk 1 X Slope (%)	9.6		X Walk 2 X Slope (%)	N/A

N/A	Ramp inside XWalk1?	N/A	N/A	Ramp inside XWalk2?	N/A
	Road Slope (%)	N/A	N/A	Clear Space?	N/A
	Road X Slope (%)	N/A	N/A	Clear Space to XWalk (in)	N/A
N/A	Any Obstructions?	N/A	N/A	Storm Grate/Utility Hazard?	N/A
	Obstruction Type			Storm Grate/Utility Type	
		N/A			N/A
			Yes	Surface Condition? (G/P)	Good

Possible Solutions:

Remove & Replace Entire Ramp.
