## **Access Compliance Report Public Rights-of-Way** (Curb Ramps)

Intersection ID: 3494 Main Street: REAMES RD Cross Street: W W T HARRIS BV Location: NW ADA ID: 34C237323800 Ramp Type: Perp Initial Pass/Fail: Fail **Overall Compliance: No Severity Score:** 22.5

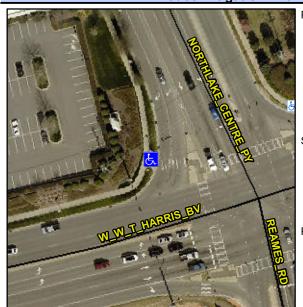
Possible Solutions:	Compli	ance	Description
Remove & Replace Entire Ramp.	N/A	Ram	p Length (in)
·	No	Ram	p Width (in)
	N/A	Flare	Type LT
	N/A	Flare	Slope LT (%)
	N/A	Flare	Traversable LT
	N/A	Land	ing Length (in)
Surveyor Notes:	N/A	Land	ing Width (in)
N/A	N/A	Land	ing Slope (%)
	N/A	Land	ing X Slope (%)
	N/A	Land	ing Curb? (Y/N)
	N/A	Share	ed Landing?
PROW/ADA:	N/A	Gutte	er Ponding?
Not Found, R304.5.1, R304.2.2,	N/A	Gutte	er Lip Ht (in)
R304.5.3	N/A	Paint	ed X Walk1?
		X Wa	lk 1 Direction
	N/A	X Wa	ılk 1 Width (in)
		X Wa	ılk 1 Slope (%)
		X Wa	ılk 1 X Slope (%
	N/A	Ram	p inside XWalk1
		Road	Slope (%)
