# Access Compliance Report

## Public Rights-of-Way

### (Curb Ramps)

| Intersection ID: 5833 | Main Street: GUM_BRANCH_RD | Cross Street: KENTBERRY_DR | Location: S |

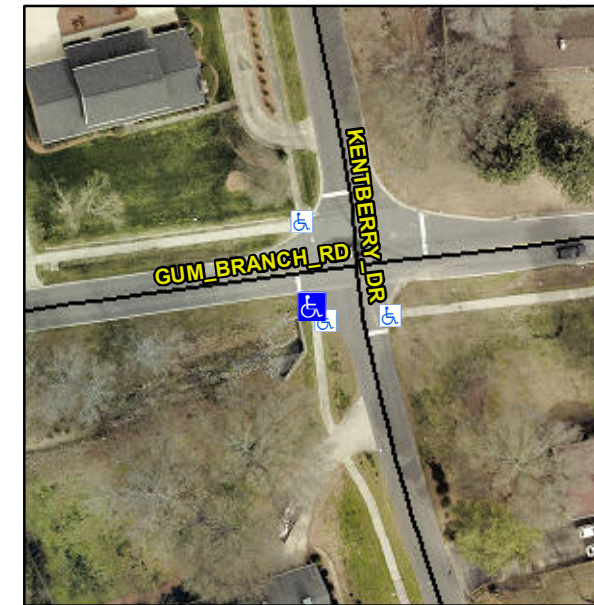
| Compliance | Description | Data | Compliance | Description | Data |
|---|---|---|---|---|---|
| N/A | Ramp Length (in) | 87.0 | Yes | Grade Break? | Yes |
| Yes | Ramp Width (in) | 58.0 | Yes | Grade Break Slope (%) | 2.1 |
| Yes | Ramp Slope (%) | 0.6 | No | Grade Break XSlope (%) | 3.1 |
| Yes | Landing X Slope (%) | 1.2 | No | DWS Full Width? | No |
| N/A | Landing Curb? (Y/N) | No | No | DWS Offset LT (in) | 5.0 |
| No | Gutter Ponding? | Yes | No | Gutter Slope (%) | 8.6 |
| No | Gutter Lip Ht (in) | 0.5 | Yes | Gutter X Slope (%) | 0.3 |

**Remove & Replace Entire Ramp.  
Remove & Replace Gutter.**
