Access Compliance Report

Public Rights-of-Way

(Curb Ramps)

Intersection ID: 9178	Main Street: BEATTIES_FORD_RD	Cross Street: TATE_ST	Location: NW
ADA ID: 34D34E44E6A8	Ramp Type: PerpDiag	Initial Pass/Fail: Fail	Overall Compliance: No
		Severity Score: 10

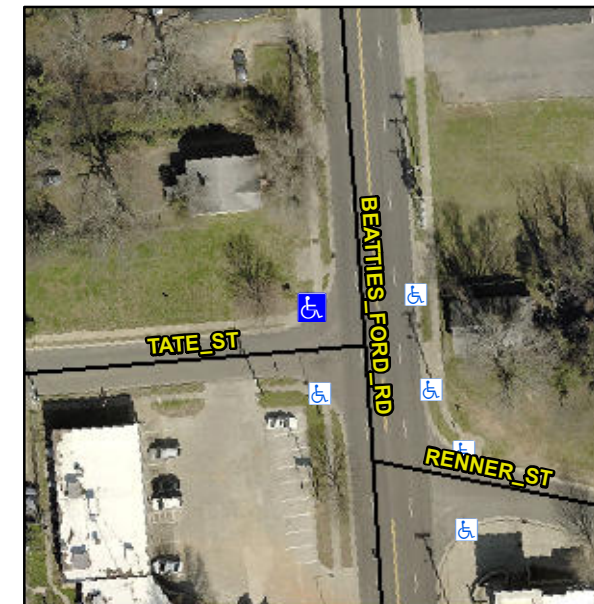
Not Found, R304.5.1, R304.5.3

Compliance	Description	Data	Compliance	Description	Data
N/A	Ramp Length (in)	60.0	Yes	Ramp Slope (%)	7.1
No	Ramp Width (in)	38.5	No	Ramp XSlope (%)	3.9
N/A	Flare Type LT	N/A	N/A	Flare Type RT	N/A
N/A	Flare Slope LT (%)	N/A	N/A	Flare Slope RT (%)	N/A
N/A	Flare Traversable LT?	N/A	N/A	Flare Traversable RT?	N/A
N/A	Landing Length (in)	N/A	N/A	DWS Provided?	N/A
N/A	Landing Width (in)	N/A	N/A	DWS Contrast?	N/A
N/A	Landing Slope (%)	N/A	N/A	DWS Length (in)	N/A
N/A	Landing X Slope (%)	N/A	N/A	DWS Full Width?	N/A
N/A	Landing Curb? (Y/N)	N/A	N/A	DWS Offset (in)	N/A
N/A	Shared Landing?	N/A			
N/A	Gutter Ponding?	N/A	N/A	Gutter Slope (%)	N/A
N/A	Gutter Lip Ht (in)	N/A	N/A	Gutter X Slope (%)	N/A
N/A	Painted X Walk1?	No	N/A	Painted X Walk2?	No
	X Walk 1 Direction	To S		X Walk 2 Direction	To E
N/A	X Walk 1 Width (in)	N/A	N/A	X Walk 2 Width (in)	N/A
	X Walk 1 Slope (%)	1.8		X Walk 2 Slope (%)	3.9
	X Walk 1 X Slope (%)	2.2		X Walk 2 X Slope (%)	0.2

N/A	Ramp inside XWalk1?	N/A	N/A	Ramp inside XWalk2?	N/A
	Road Slope (%)	0.4	N/A	Clear Space?	N/A
	Road X Slope (%)	1.3	N/A	Clear Space to XWalk (in)	N/A
N/A	Any Obstructions?	N/A	N/A	Storm Grate/Utility Hazard?	N/A
	Obstruction Type			Storm Grate/Utility Type	
		N/A			N/A
			Yes	Surface Condition? (G/P)	Good

Remove & Replace Curb Ramp With Two New Directional Ramps or Equivalent.
