# Access Compliance Report

## Public Rights-of-Way

### (Curb Ramps)

Intersection ID: 24180	Main Street: CANDLEWYCK_LN	Cross Street: STONERIDGE_RD	Location: NE
ADA ID: 34D9B8409FDD	Ramp Type: PerpDiag	Initial Pass/Fail: Fail	Overall Compliance: No
Severity Score: 25			
Codes/Mitigation Info/Possible Solution		Field Measurements/Component Compliance

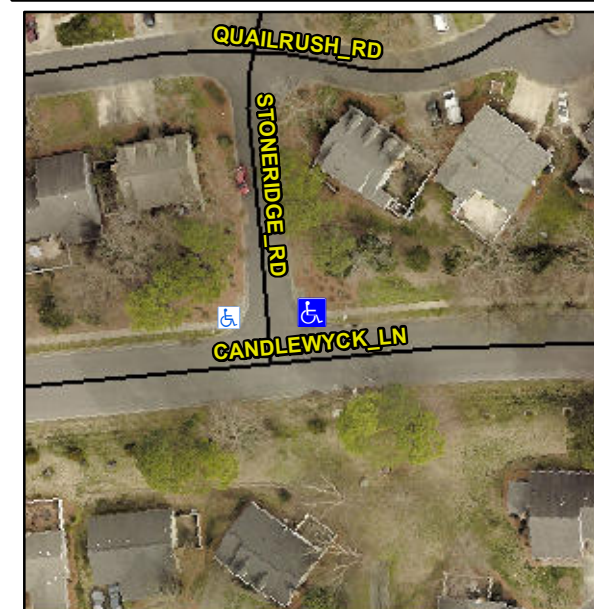
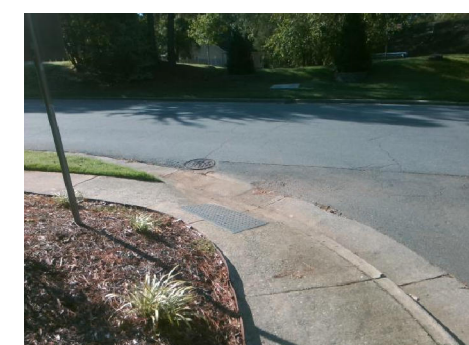
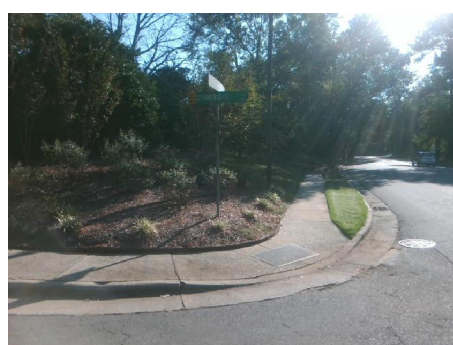
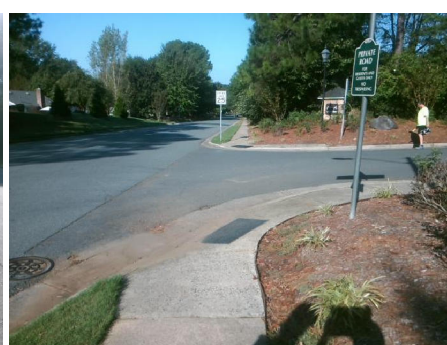
Compliance	Description	Data	Compliance	Description	Data
N/A	Ramp Length (in)	45.0	No	Ramp Slope (%)	14.9
Yes	Ramp Width (in)	48.0	Yes	Ramp XSlope (%)	1.6
N/A	Flare Type LT	N/A	N/A	Flare Type RT	N/A
N/A	Flare Slope LT (%)	N/A	N/A	Flare Slope RT (%)	N/A
N/A	Flare Traversable LT?	N/A	N/A	Flare Traversable RT?	N/A
N/A	Landing Length (in)	N/A	N/A	DWS Provided?	N/A
N/A	Landing Width (in)	N/A	N/A	DWS Contrast?	N/A
N/A	Landing Slope (%)	N/A	N/A	DWS Length (in)	N/A
N/A	Landing X Slope (%)	N/A	N/A	DWS Full Width?	N/A
N/A	Landing Curb? (Y/N)	N/A	N/A	DWS Offset (in)	N/A
N/A	Shared Landing?	N/A			
N/A	Gutter Ponding?	N/A	N/A	Gutter Slope (%)	N/A
N/A	Gutter Lip Ht (in)	N/A	N/A	Gutter X Slope (%)	N/A
N/A	Painted X Walk1?	No	N/A	Painted X Walk2?	No
	X Walk 1 Direction	To W		X Walk 2 Direction	To S
N/A	X Walk 1 Width (in)	N/A	N/A	X Walk 2 Width (in)	N/A
	X Walk 1 Slope (%)	0.0		X Walk 2 Slope (%)	2.1
	X Walk 1 X Slope (%)	1.9		X Walk 2 X Slope (%)	1.0

N/A	Ramp inside XWalk1?	N/A	N/A	Ramp inside XWalk2?	N/A
	Road Slope (%)	3.3	N/A	Clear Space?	N/A
	Road X Slope (%)	4.4	N/A	Clear Space to XWalk (in)	N/A
N/A	Any Obstructions?	N/A	N/A	Storm Grate/Utility Hazard?	N/A
	Obstruction Type			Storm Grate/Utility Type	
		N/A			N/A
		Yes		Surface Condition? (G/P)	Good

**Remove & Replace Curb Ramp With Two New Directional Ramps or Equivalent.**

Total Cost: \$ 3200.00
