Access Compliance Report

Public Rights-of-Way

(Curb Ramps)

| Intersection ID: 2698 | Main Street: GRABURN'S_FORD_DR | Cross Street: HIGHLAND_CREEK_PY | Location: NE |

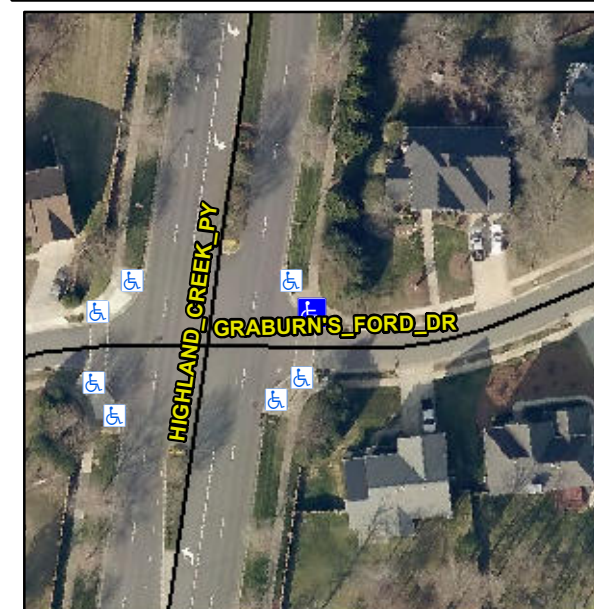
| ADA ID: 34DEBDC75A3D | Ramp Type: Perp | Initial Pass/Fail: Fail | Overall Compliance: No |
| Severity Score: 33.75 | | | |

R304.5.1, R304.2.2, R304.5.3

| Compliance | Description | Data | Compliance | Description | Data |
|---|---|---|---|---|---|
| N/A | Ramp Length (in) | 66.0 | No | Ramp Slope (%) | 8.7 |
| No | Ramp Width (in) | 47.0 | No | Ramp XSlope (%) | 5.6 |

Possible Solutions:

Remove & Replace Entire Ramp.
