# Access Compliance Report

## Public Rights-of-Way

### (Curb Ramps)

| Intersection ID: 30677 | Main Street: DIXIE_HILLS_DR | Cross Street: MARVIN_RD | Location: SE |

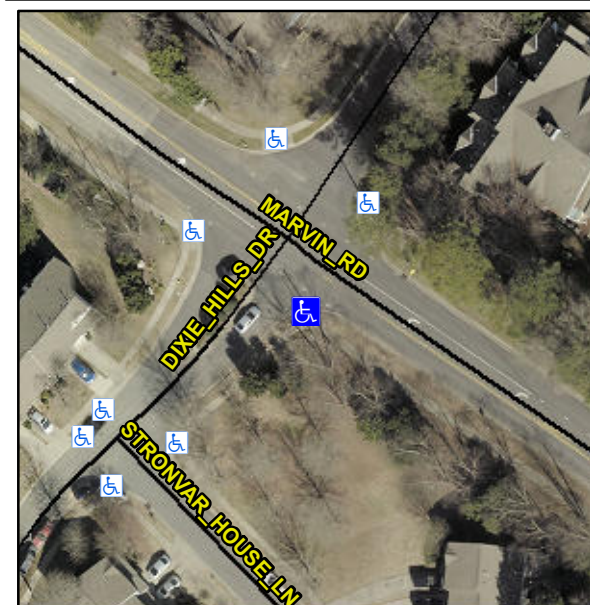
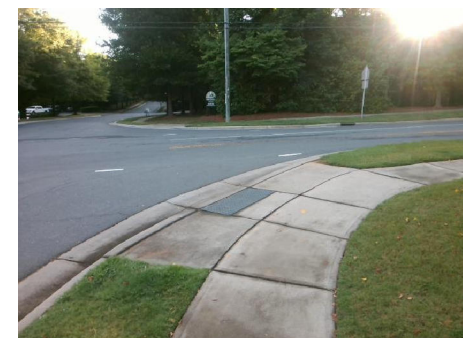
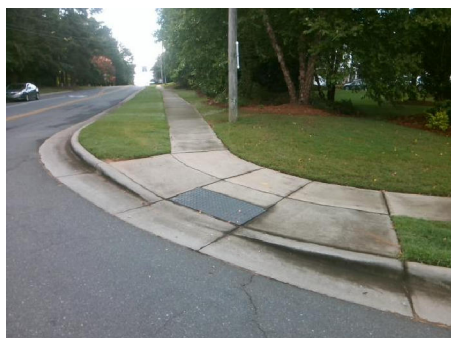
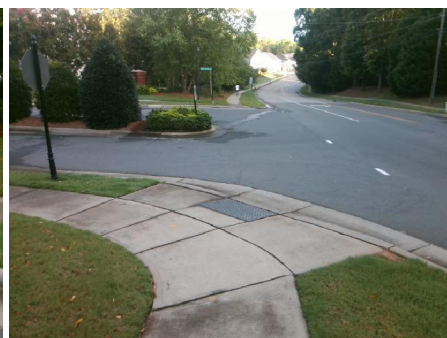
| ADA ID: 34E33B7CC6E7 | Ramp Type: Combination1Diag | Initial Pass/Fail: Fail | Overall Compliance: No |

**Not Found, R304.5.1, R304.5.1, R304.2.2, R304.5.3, R304.3.2**

| Compliance | Description | Data | Compliance | Description | Data |
|---|---|---|---|---|---|
| Yes | Ramp Width LT (in) | 51.0 | No | Ramp Width RT (in) | 47.0 |
| No | Ramp Slope LT (%) | 14.2 | Yes | Ramp Slope RT (%) | 7.3 |
| N/A | Ramp Length (in) | 46.0 | No | Ramp Slope (%) | 8.6 |
| No | Ramp Width (in) | 45.0 | No | Ramp XSlope (%) | 10.5 |

**Remove & Replace Curb Ramp With Two New Directional Ramps or Equivalent.**

Total Cost: \$ 3200.00
