Access Compliance Report Public Rights-of-Way (Curb Ramps)

Intersection ID: 19121 Main Street: MILLBURY CT Cross Street: RAMA RD Location: SE **Overall Compliance: No** ADA ID: 34EEDA850C59 Ramp Type: PerpDiag Initial Pass/Fail: Fail **Severity Score:** 50

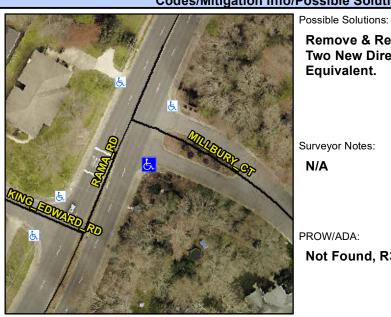
Surveyor Notes:		
N/A		
PROW/ADA:		
Not Found, R304.2.2,	R304.5.3	
Total Cost	¢	3200.00

Compl	ance Description	Data	Compl	iance Description	Data
N/A	Ramp Length (in)	61.0	No	Ramp Slope (%)	12.3
Yes	Ramp Width (in)	48.0	No	Ramp XSlope (%)	13.8
N/A	Flare Type LT	N/A	N/A	Flare Type RT	N/A
N/A	Flare Slope LT (%)	N/A	N/A	Flare Slope RT (%)	N/A
N/A	Flare Traversable LT?	N/A	N/A	Flare Traversable RT?	N/A
N/A	Landing Length (in)	N/A	N/A	DWS Provided?	N/A
N/A	Landing Width (in)	N/A	N/A	DWS Contrast?	N/A
N/A	Landing Slope (%)	N/A	N/A	DWS Length (in)	N/A
N/A	Landing X Slope (%)	N/A	N/A	DWS Full Width?	N/A
N/A	Landing Curb? (Y/N)	N/A	N/A	DWS Offset (in)	N/A
N/A	Shared Landing?	N/A			
N/A	Gutter Ponding?	N/A	N/A	Gutter Slope (%)	N/A
N/A	Gutter Lip Ht (in)	N/A	N/A	Gutter X Slope (%)	N/A
N/A	Painted X Walk1?	No	N/A	Painted X Walk2?	No
	X Walk 1 Direction	To NE		X Walk 2 Direction	To NW
N/A	X Walk 1 Width (in)	N/A	N/A	X Walk 2 Width (in)	N/A
	X Walk 1 Slope (%)	3.0		X Walk 2 Slope (%)	9.3
	X Walk 1 X Slope (%)	9.0		X Walk 2 X Slope (%)	4.7

N/A	Ramp inside XWalk1?	N/A	N/A	Ramp inside XWalk2?	N/A
	Road Slope (%)	9.2	N/A	Clear Space?	N/A
	Road X Slope (%)	4.5	N/A	Clear Space to XWalk (in)	N/A
N/A	Any Obstructions?	N/A	N/A	Storm Grate/Utility Hazard?	N/A
	Obstruction Type		l	Storm Grate/Utility Type	
		N/A			N/A
			Yes	Surface Condition? (G/P)	Good

Street 1 Name **MILLBURY CT** Stop Condition-Street 2 StopSign Street 2 Name **RAMA RD** Stop Condition-Street 1 None Remove & Replace Curb Ramp With Two New Directional Ramps or Equivalent.

•	
Total Cost:	\$ 3200.00
