# Access Compliance Report

## Public Rights-of-Way

### (Curb Ramps)

| Intersection ID: 5515 | Main Street: NORTHWOODS_FOREST_DR | Cross Street: RUNNING_BROOK_RD | Location: NW |

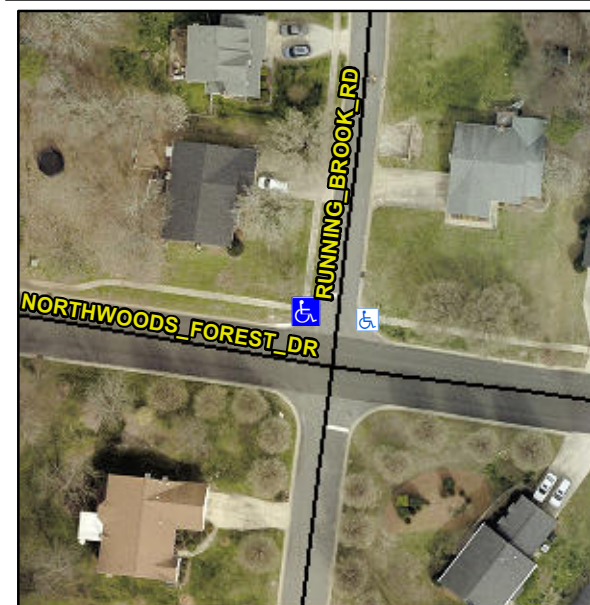
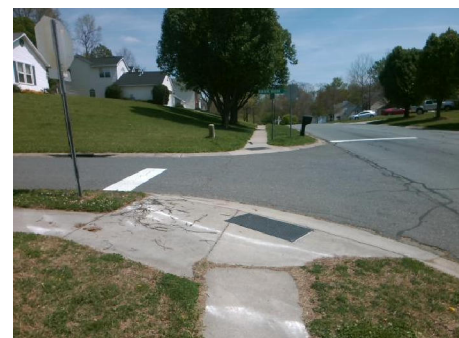
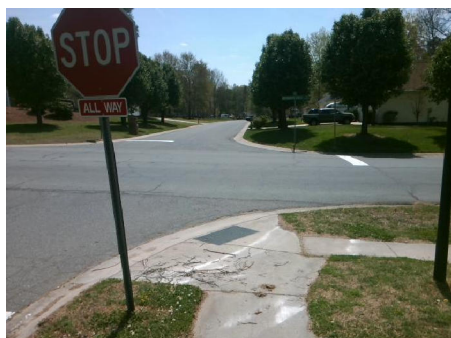
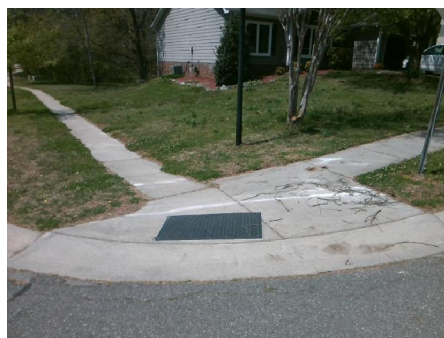
| ADA ID: 34F72ABA0C2A | Ramp Type: BlendTrans2 | Initial Pass/Fail: Fail | Overall Compliance: No |

**Not Found, R304.5.3**

| Compliance | Description | Data | Compliance | Description | Data |
|---|---|---|---|---|---|
| Yes | Ramp Width (in) | 48.0 | No | BlendTrans XSlope (%) | 9.0 |
| | | | No | Curb Slope (%) | 16.2 |

**Remove & Replace Curb Ramp With Two New Directional Ramps or Equivalent.**
