Access Compliance Report

Public Rights-of-Way

(Curb Ramps)

| Intersection ID: 43666 | Main Street: CORSICA_FOREST_DR | Cross Street: ASHETON_CREEK_DR | Location: NE |

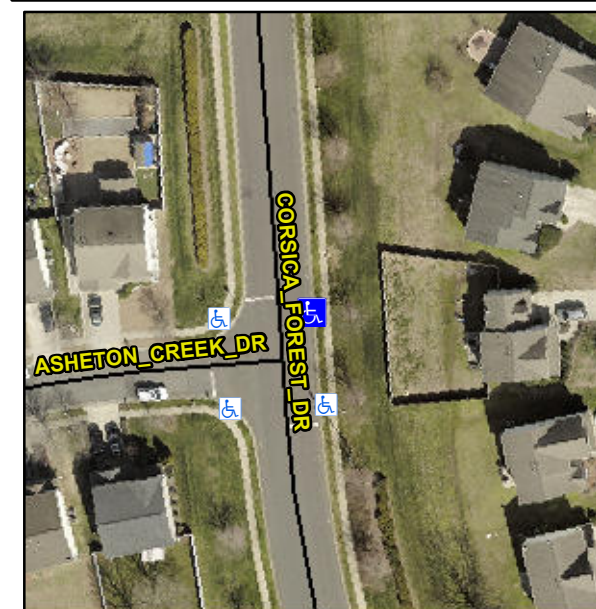
| ADA ID: 3500221F03B8 | Ramp Type: Perp | Initial Pass/Fail: Fail | Overall Compliance: No |

Not Found, R304.2.2

| Compliance | Description | Data | Compliance | Description | Data |
|---|---|---|---|---|---|
| N/A | Ramp Length (in) | 46.0 | No | Ramp Slope (%) | 11.8 |

Remove & Replace Entire Ramp.

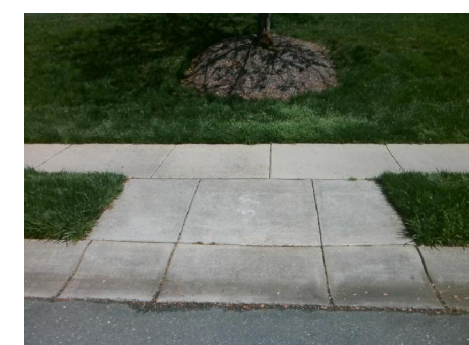
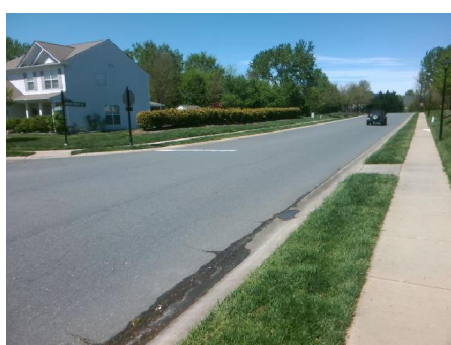
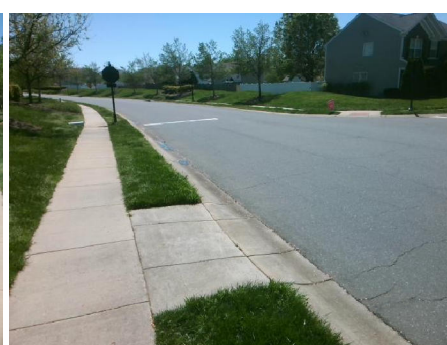
| Compliance | Description | Data | Compliance | Description | Data |
|---|---|---|---|---|---|
| Yes | Ramp Width (in) | 48.0 | Yes | Ramp XSlope (%) | 2.0 |
| | | | Yes | Surface Condition? (G/P) | Good |
