Access Compliance Report Public Rights-of-Way (Curb Ramps)

Intersection ID: 30154 Main Street: ALSTON HILL DR Cross Street: RED BUD CR Location: NW ADA ID: 351E2D7E614E Ramp Type: PerpDiag Initial Pass/Fail: Fail **Overall Compliance: No Severity Score:** 10

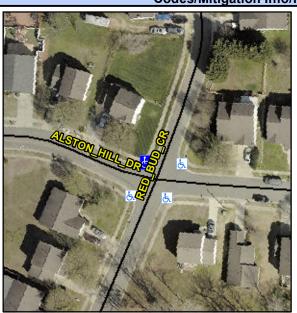
Field Measurements/Component Compliance							
	Compliance Description		Data	Compliance Description		Data	
	N/A	Ramp Length (in)	41.0	Yes	Ramp	Slope (%)	8.1
	No	Ramp Width (in)	43.0	No	Ramp	xSlope (%)	3.1
	N/A	Flare Type LT	N/A	N/A	Flare	Type RT	N/A
	N/A	Flare Slope LT (%)	N/A	N/A	Flare	Slope RT (%)	N/A
	N/A	Flare Traversable LT?	N/A	N/A	Flare	Traversable RT?	N/A
	N/A	Landing Length (in)	N/A	N/A	DWS	Provided?	N/A
	N/A	Landing Width (in)	N/A	N/A	DWS	Contrast?	N/A
	N/A	Landing Slope (%)	N/A	N/A	DWS	Length (in)	N/A
	N/A	Landing X Slope (%)	N/A	N/A	DWS	Full Width?	N/A
	N/A	Landing Curb? (Y/N)	N/A	N/A	DWS	Offset (in)	N/A
	N/A	Shared Landing?	N/A				
	N/A	Gutter Ponding?	N/A	N/A	Gutte	er Slope (%)	N/A
	N/A	Gutter Lip Ht (in)	N/A	N/A	Gutte	er X Slope (%)	N/A
	N/A	Painted X Walk1?	No	N/A	Paint	ed X Walk2?	No
		X Walk 1 Direction	To S		X Wa	lk 2 Direction	То Е
	N/A	X Walk 1 Width (in)	N/A	N/A	X Wa	ılk 2 Width (in)	N/A

X Walk 1 Slope (%)	4.6		X Wa	lk 2 Slope (%)	2.6
		X Walk 1 X Slope (%)	2.0		X Wa	lk 2 X Slope (%)	3.5
	N/A	Ramp inside XWalk1?	N/A	N/A	Ram	o inside XWalk2?	N/A
		Road Slope (%)	4.2	N/A	Clear	Space?	N/A
		Road X Slope (%)	2.9	N/A	Clear	Space to XWalk (in)	N/A
	N/A	Any Obstructions?	N/A	N/A	Storn	n Grate/Utility Hazard?	N/A
		Obstruction Type			Storn	n Grate/Utility Type	
			N/A				N/A
				Yes	Surfa	ce Condition? (G/P)	Good
	is 89256s4 .	AND THE PROPERTY AND THE PARTY

Possible Solutions: Remove & Replace Curb Ramp With **Two New Directional Ramps or** Equivalent. Surveyor Notes: N/A PROW/ADA: Not Found, R304.5.1, R304.5.3
