## Access Compliance Report Public Rights-of-Way (Curb Ramps)

Intersection ID: 22076 Main Street: HEATHSTEAD\_PL Cross Street: QUAIL\_HOLLOW\_RD Location: SE

ADA ID: 351F81FBDBBA Ramp Type: PerpDiag Initial Pass/Fail: Fail Overall Compliance: No Severity Score: 36.25

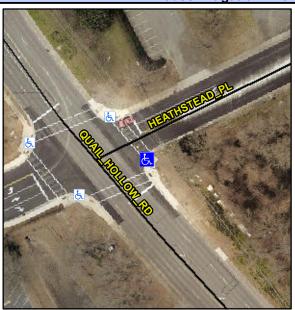
Field Measurements/Component Compliance					
Compliance Description		Data	Comp	oliance Description	Data
N/A	Ramp Length (in)	61.0	Yes	Ramp Slope (%)	5.0
No	Ramp Width (in)	28.0	No	Ramp XSlope (%)	3.3
N/A	Flare Type LT	N/A	N/A	Flare Type RT	N/A
N/A	Flare Slope LT (%)	N/A	N/A	Flare Slope RT (%)	N/A
N/A	Flare Traversable LT?	N/A	N/A	Flare Traversable RT?	N/A
N/A	Landing Length (in)	N/A	N/A	DWS Provided?	N/A
N/A	Landing Width (in)	N/A	N/A	DWS Contrast?	N/A
N/A	Landing Slope (%)	N/A	N/A	DWS Length (in)	N/A
N/A	Landing X Slope (%)	N/A	N/A	DWS Full Width?	N/A
N/A	Landing Curb? (Y/N)	N/A	N/A	DWS Offset (in)	N/A
N/A	Shared Landing?	N/A			
N/A	Gutter Ponding?	N/A	N/A	Gutter Slope (%)	N/A
N/A	Gutter Lip Ht (in)	N/A	N/A	Gutter X Slope (%)	N/A
N/A	Painted X Walk1?	No	N/A	Painted X Walk2?	No
	X Walk 1 Direction	To NW		X Walk 2 Direction	To SW
N/A	X Walk 1 Width (in)	N/A	N/A	X Walk 2 Width (in)	N/A
	X Walk 1 Slope (%)	2.7		X Walk 2 Slope (%)	3.2

X Walk 1 X Slope (%)	1.2		X Walk 2 X Slope (%)	0.7
N/A	Ramp inside XWalk1?	N/A	N/A	Ramp inside XWalk2?	N/A
	Road Slope (%)	2.6	N/A	Clear Space?	N/A
	Road X Slope (%)	1.1	N/A	Clear Space to XWalk (in)	N/A
N/A	Any Obstructions?	N/A	N/A	Storm Grate/Utility Hazard?	N/A
	Obstruction Type		l	Storm Grate/Utility Type	
		N/A			N/A
			Yes	Surface Condition? (G/P)	Good
Market I

Remove & Replace Curb Ramp With Two New Directional Ramps or Equivalent.
