# Access Compliance Report

## Public Rights-of-Way

### (Curb Ramps)

Intersection ID: 11659	Main Street: E_16TH_ST	Cross Street: N_DAVIDSON_ST	Location: S
ADA ID: 353187BB78BF	Ramp Type: PerpDiag	Initial Pass/Fail: Fail	Overall Compliance: No
		Severity Score: 12.5

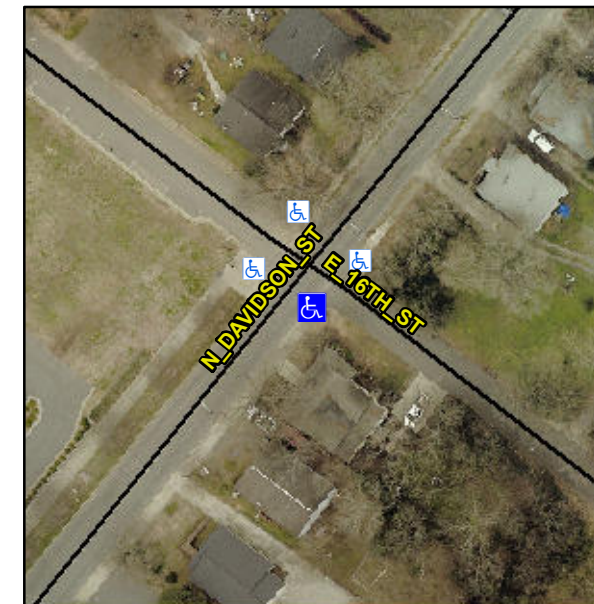
**Not Found, R304.2.2**

Compliance	Description	Data	Compliance	Description	Data
N/A	Ramp Length (in)	56.0	No	Ramp Slope (%)	8.5
Yes	Ramp Width (in)	55.0	Yes	Ramp XSlope (%)	0.8
N/A	Flare Type LT	N/A	N/A	Flare Type RT	N/A
N/A	Flare Slope LT (%)	N/A	N/A	Flare Slope RT (%)	N/A
N/A	Flare Traversable LT?	N/A	N/A	Flare Traversable RT?	N/A
N/A	Landing Length (in)	N/A	N/A	DWS Provided?	N/A
N/A	Landing Width (in)	N/A	N/A	DWS Contrast?	N/A
N/A	Landing Slope (%)	N/A	N/A	DWS Length (in)	N/A
N/A	Landing X Slope (%)	N/A	N/A	DWS Full Width?	N/A
N/A	Landing Curb? (Y/N)	N/A	N/A	DWS Offset (in)	N/A
N/A	Shared Landing?	N/A			
N/A	Gutter Ponding?	N/A	N/A	Gutter Slope (%)	N/A
N/A	Gutter Lip Ht (in)	0.5	N/A	Gutter X Slope (%)	N/A
N/A	Painted X Walk1?	No	N/A	Painted X Walk2?	No
	X Walk 1 Direction	To NE		X Walk 2 Direction	To NW
N/A	X Walk 1 Width (in)	N/A	N/A	X Walk 2 Width (in)	N/A
	X Walk 1 Slope (%)	1.0		X Walk 2 Slope (%)	0.2
	X Walk 1 X Slope (%)	2.3		X Walk 2 X Slope (%)	3.3

N/A	Ramp inside XWalk1?	N/A	N/A	Ramp inside XWalk2?	N/A
	Road Slope (%)	0.2	N/A	Clear Space?	N/A
	Road X Slope (%)	2.2	N/A	Clear Space to XWalk (in)	N/A
N/A	Any Obstructions?	N/A	N/A	Storm Grate/Utility Hazard?	N/A
	Obstruction Type			Storm Grate/Utility Type	
		N/A			N/A
			Yes	Surface Condition? (G/P)	Good

**Remove & Replace Curb Ramp With Two New Directional Ramps or Equivalent.**

Total Cost: \$ 3200.00
