# Access Compliance Report

## Public Rights-of-Way

| Intersection ID: 10866 | Main Street: DALTON_AV | Cross Street: PLYMOUTH_AV | Location: NW |
| ADA ID: 353780BC095F | Ramp Type: PerpDiag | Initial Pass/Fail: Fail | Overall Compliance: No |

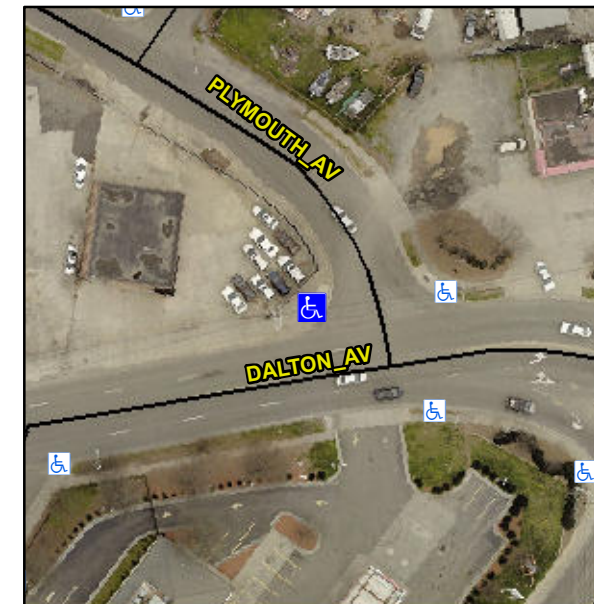
**Not Found, R304.5.1, R304.5.3**

| Compliance | Description | Data | Compliance | Description | Data |
|---|---|---|---|---|---|
| N/A | Ramp Length (in) | 67.5 | Yes | Ramp Slope (%) | 7.1 |
| No | Ramp Width (in) | 45.0 | No | Ramp XSlope (%) | 4.6 |

**Remove & Replace Curb Ramp With Two New Directional Ramps or Equivalent.**
