Access Compliance Report

Public Rights-of-Way

(Curb Ramps)

Intersection ID: 44909	Main Street: PALUSTRIS_CT	Cross Street: OAKBURN_DR	Location: SW
ADA ID: 354EFD4113	Ramp Type: PerpDiag	Initial Pass/Fail: Fail	Overall Compliance: No
			Severity Score: 33.75

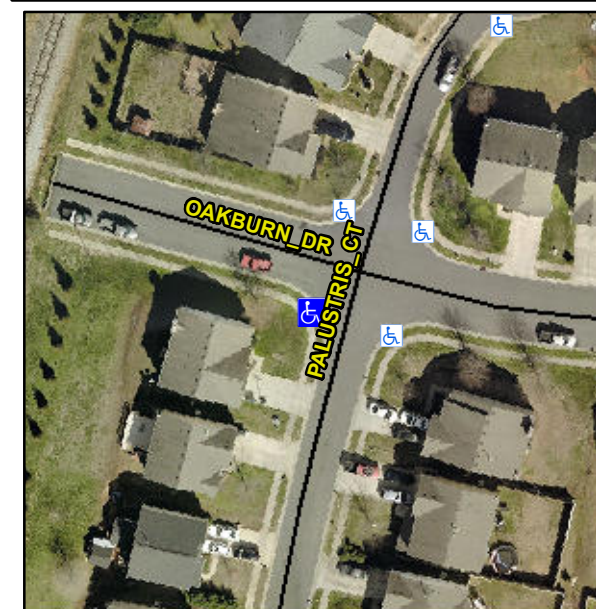
Not Found, R304.5.1, R304.5.3

Compliance	Description	Data	Compliance	Description	Data
N/A	Ramp Length (in)	46.0	Yes	Ramp Slope (%)	7.4
No	Ramp Width (in)	44.0	No	Ramp XSlope (%)	8.4
N/A	Flare Type LT	N/A	N/A	Flare Type RT	N/A
N/A	Flare Slope LT (%)	N/A	N/A	Flare Slope RT (%)	N/A
N/A	Flare Traversable LT?	N/A	N/A	Flare Traversable RT?	N/A
N/A	Landing Length (in)	N/A	N/A	DWS Provided?	N/A
N/A	Landing Width (in)	N/A	N/A	DWS Contrast?	N/A
N/A	Landing Slope (%)	N/A	N/A	DWS Length (in)	N/A
N/A	Landing X Slope (%)	N/A	N/A	DWS Full Width?	N/A
N/A	Landing Curb? (Y/N)	N/A	N/A	DWS Offset (in)	N/A
N/A	Shared Landing?	N/A			
N/A	Gutter Ponding?	N/A	N/A	Gutter Slope (%)	N/A
N/A	Gutter Lip Ht (in)	N/A	N/A	Gutter X Slope (%)	N/A
N/A	Painted X Walk1?	No	N/A	Painted X Walk2?	No
	X Walk 1 Direction	To SE		X Walk 2 Direction	To NE
N/A	X Walk 1 Width (in)	N/A	N/A	X Walk 2 Width (in)	N/A
	X Walk 1 Slope (%)	1.3		X Walk 2 Slope (%)	6.6
	X Walk 1 X Slope (%)	7.3		X Walk 2 X Slope (%)	3.8

N/A	Ramp inside XWalk1?	N/A	N/A	Ramp inside XWalk2?	N/A
	Road Slope (%)	7.6	N/A	Clear Space?	N/A
	Road X Slope (%)	1.3	N/A	Clear Space to XWalk (in)	N/A
N/A	Any Obstructions?	N/A	N/A	Storm Grate/Utility Hazard?	N/A
	Obstruction Type			Storm Grate/Utility Type	
		N/A			N/A
			Yes	Surface Condition? (G/P)	Good

Remove & Replace Curb Ramp With Two New Directional Ramps or Equivalent.
