# Access Compliance Report

## Public Rights-of-Way

### (Curb Ramps)

| Intersection ID: 21151 | Main Street: CARMEL_RD | Cross Street: MULLENS_FORD_RD | Location: SW |

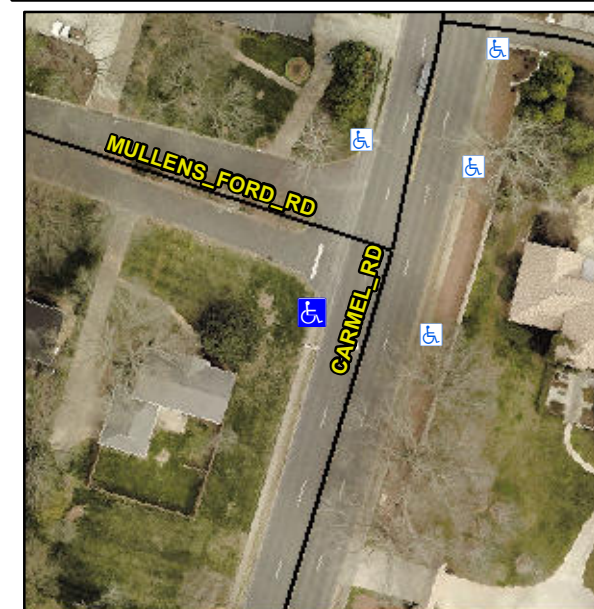
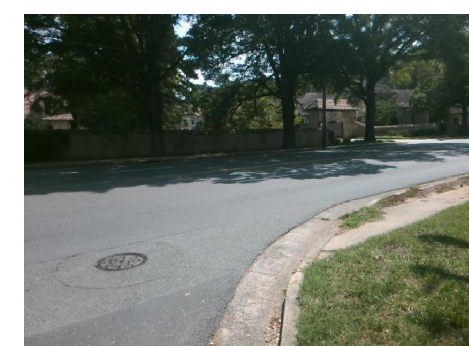
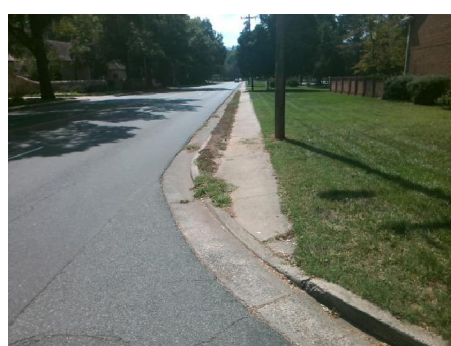
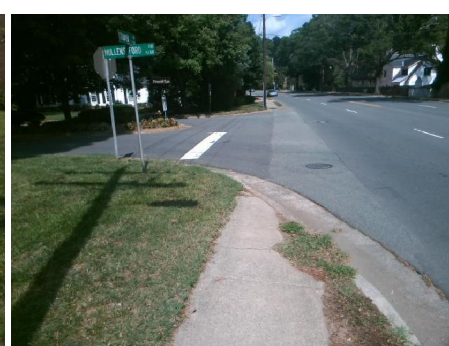
| ADA ID: 35616101D1B7 | Ramp Type: PerpDiag | Initial Pass/Fail: Fail | Overall Compliance: No |
| Severity Score: 26.25 | | | |

| Compliance | Description | Data | Compliance | Description | Data |
|---|---|---|---|---|---|
| N/A | Ramp Length (in) | 29.0 | No | Ramp Slope (%) | 16.1 |
| Yes | Ramp Width (in) | 48.0 | No | Ramp XSlope (%) | 3.4 |

**Remove & Replace Curb Ramp With Two New Directional Ramps or Equivalent.**

**R304.2.2, R304.5.3**

Total Cost: \$ 3200.00
