Access Compliance Report

Public Rights-of-Way

(Curb Ramps)

Intersection ID: 28976	Main Street: BANNINGTON_RD	Cross Street: CARMEL_COMMONS_BV	Location: SW
ADA ID: 35691446632F	Ramp Type: PerpDiag	Initial Pass/Fail: Fail	Overall Compliance: No
Severity Score: 33.75			
Codes/Mitigation Info/Possible Solution		Field Measurements/Component Compliance

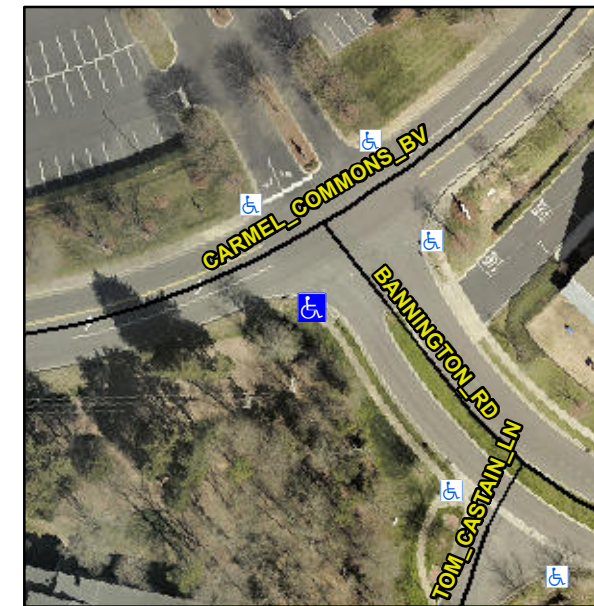
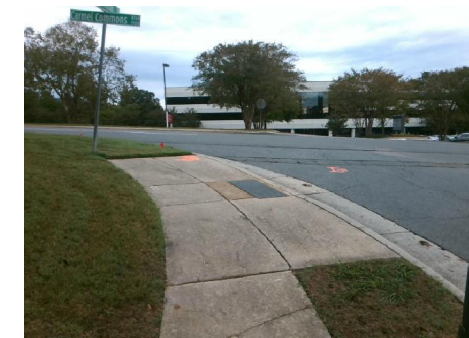
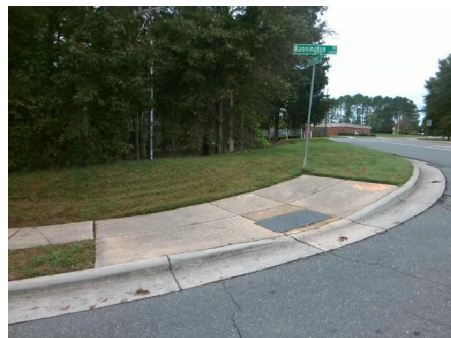
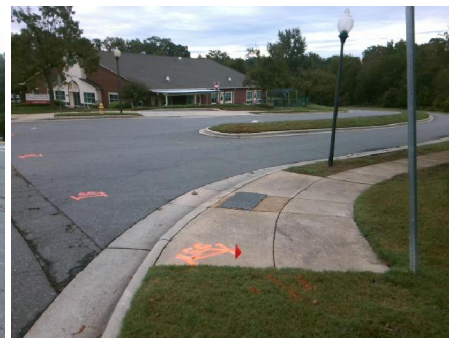
R304.5.1, R304.5.3

Compliance	Description	Data	Compliance	Description	Data
N/A	Ramp Length (in)	96.0	Yes	Ramp Slope (%)	6.5
No	Ramp Width (in)	41.0	No	Ramp XSlope (%)	10.6
N/A	Flare Type LT	N/A	N/A	Flare Type RT	N/A
N/A	Flare Slope LT (%)	N/A	N/A	Flare Slope RT (%)	N/A
N/A	Flare Traversable LT?	N/A	N/A	Flare Traversable RT?	N/A
N/A	Landing Length (in)	N/A	N/A	DWS Provided?	N/A
N/A	Landing Width (in)	N/A	N/A	DWS Contrast?	N/A
N/A	Landing Slope (%)	N/A	N/A	DWS Length (in)	N/A
N/A	Landing X Slope (%)	N/A	N/A	DWS Full Width?	N/A
N/A	Landing Curb? (Y/N)	N/A	N/A	DWS Offset (in)	N/A
N/A	Shared Landing?	N/A			
N/A	Gutter Ponding?	N/A	N/A	Gutter Slope (%)	N/A
N/A	Gutter Lip Ht (in)	N/A	N/A	Gutter X Slope (%)	N/A
N/A	Painted X Walk1?	No	N/A	Painted X Walk2?	No
	X Walk 1 Direction	To E		X Walk 2 Direction	To N
N/A	X Walk 1 Width (in)	N/A	N/A	X Walk 2 Width (in)	N/A
	X Walk 1 Slope (%)	2.4		X Walk 2 Slope (%)	8.5
	X Walk 1 X Slope (%)	8.6		X Walk 2 X Slope (%)	4.0

N/A	Ramp inside XWalk1?	N/A	N/A	Ramp inside XWalk2?	N/A
	Road Slope (%)	10.1	N/A	Clear Space?	N/A
	Road X Slope (%)	1.2	N/A	Clear Space to XWalk (in)	N/A
N/A	Any Obstructions?	N/A	N/A	Storm Grate/Utility Hazard?	N/A
	Obstruction Type			Storm Grate/Utility Type	
		N/A			N/A
		Yes		Surface Condition? (G/P)	Good

Remove & Replace Curb Ramp With Two New Directional Ramps or Equivalent.

Total Cost: \$ 3200.00
