# Access Compliance Report

## Public Rights-of-Way

### (Curb Ramps)

| Intersection ID: 10156 | Main Street: BEATTIES_FORD_RD | Cross Street: MILL_RD | Location: SW |

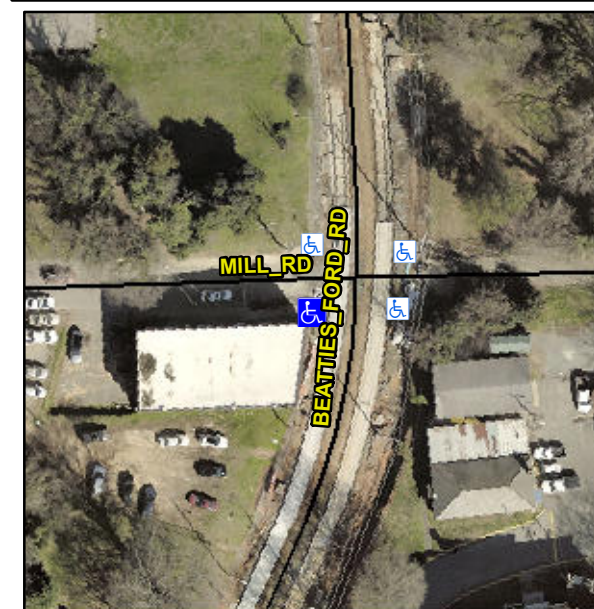
**Not Found, R304.2.2**

| Compliance | Description | Data | Compliance | Description | Data |
|---|---|---|---|---|---|
| N/A | Ramp Length (in) | 49.0 | No | Ramp Slope (%) | 14.1 |
| N/A | Gutter Ponding? | Yes | N/A | Gutter Slope (%) | N/A |

**Remove & Replace Curb Ramp With Two New Directional Ramps or Equivalent.**
